# Fæstningens Materialgård

Udgivet af Realdania Byg

Fæstningens Materialgård  
The Fortifications Depot

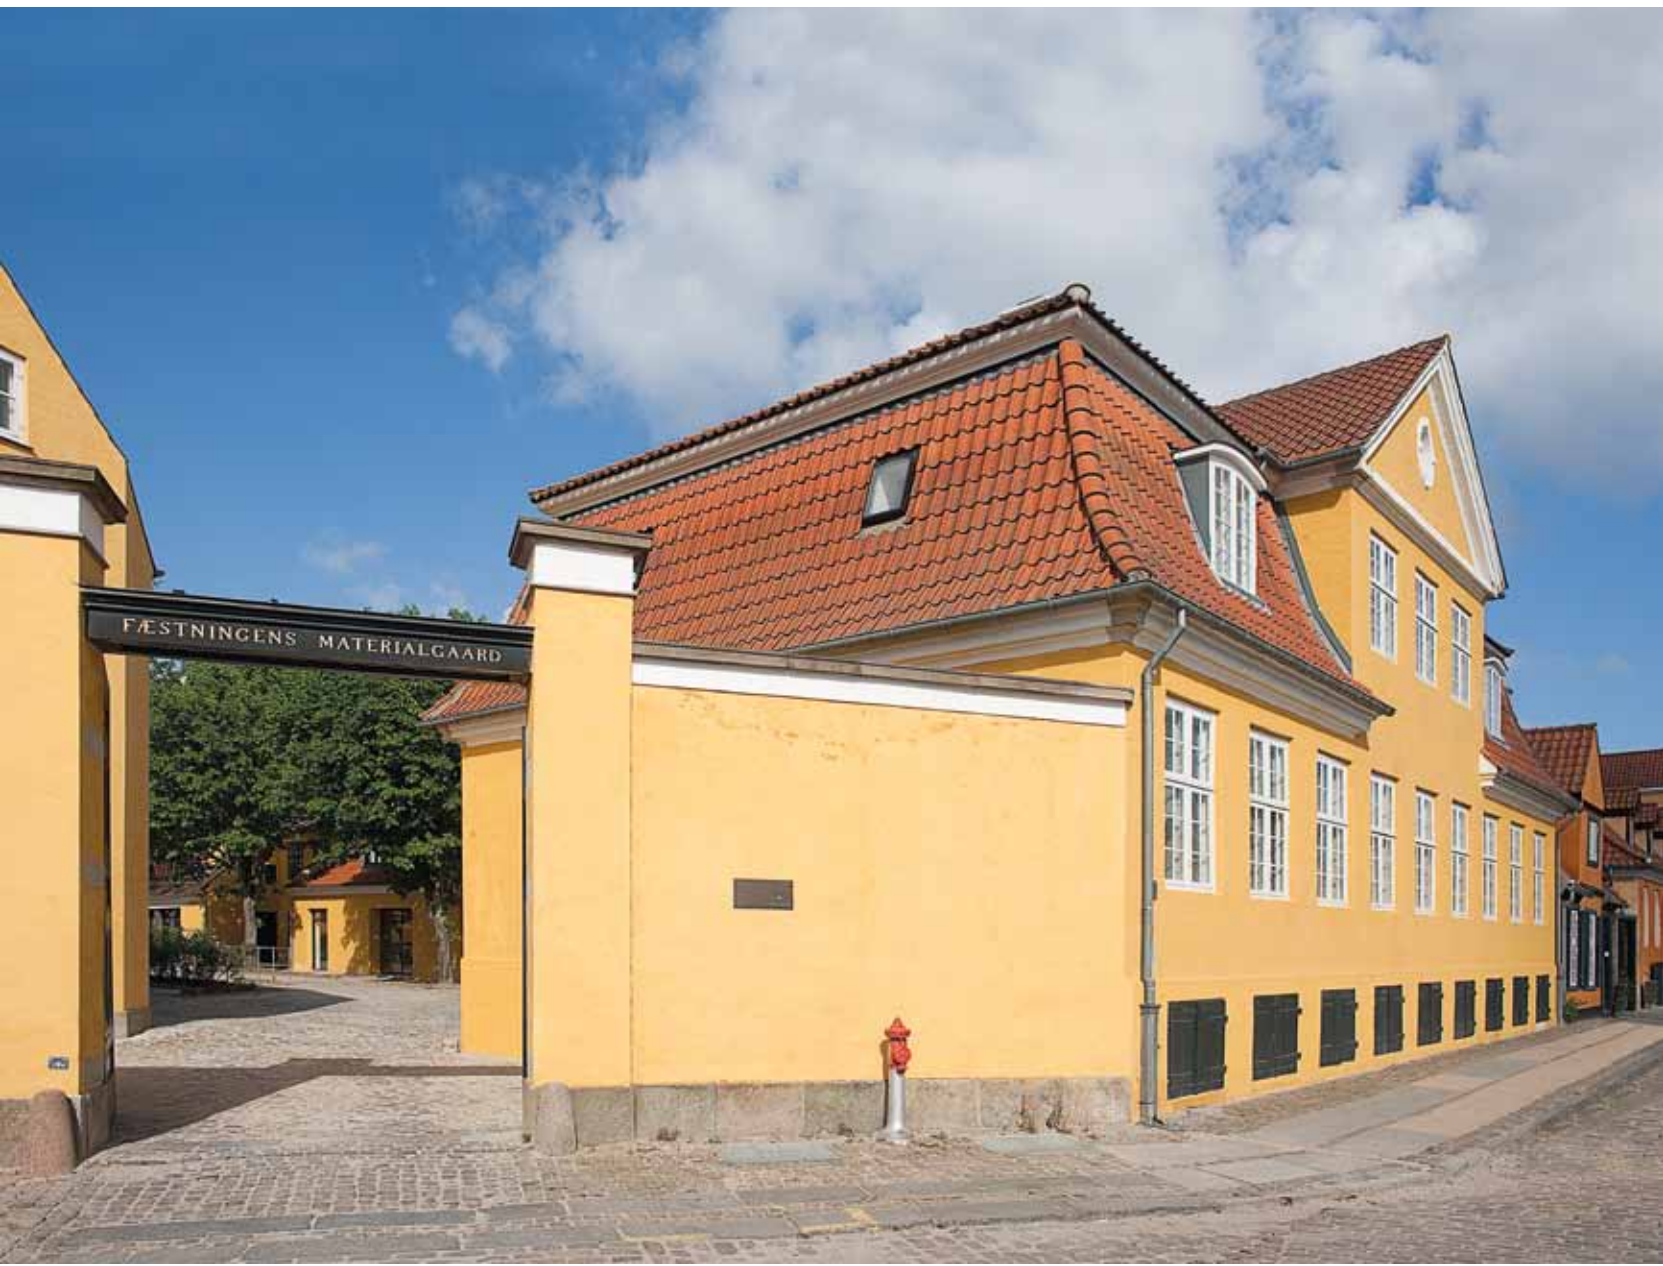
*Grund og Facade. Tegning af Materialforvalterens Tæsnig.*

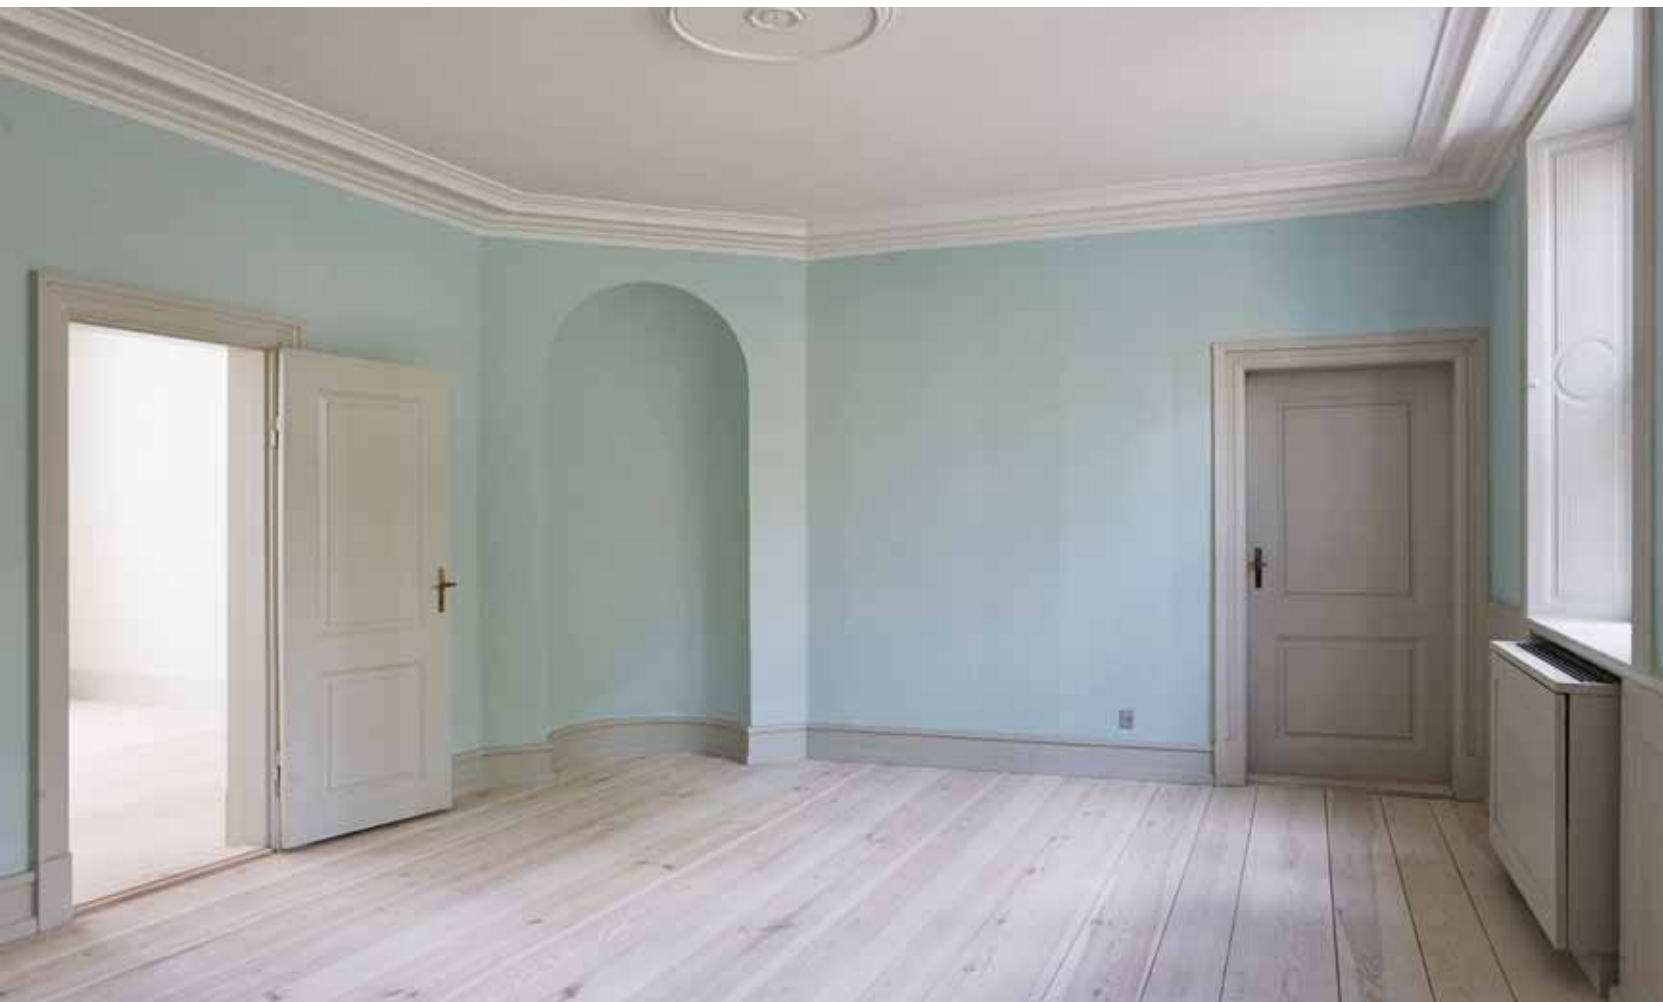
*The interiors no longer reflect the original  
warehouse function, only the building's later  
use as offices, a drafting office, and apartments.*

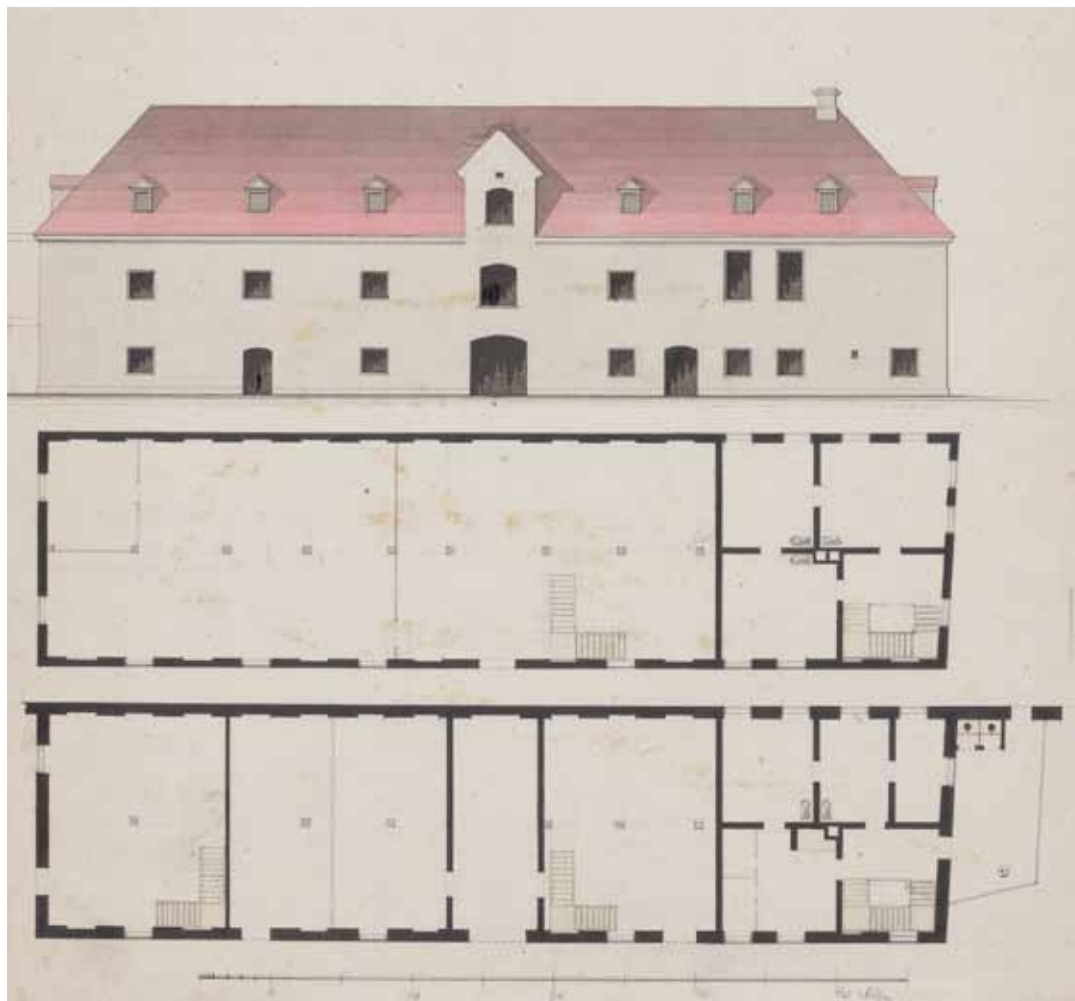
*Magasinbygningen fra 1768 er dybtgående præget af den successive omdannelse til bolig og kontor.*

*The Magazine from 1768 was profoundly affected by the transformations.*

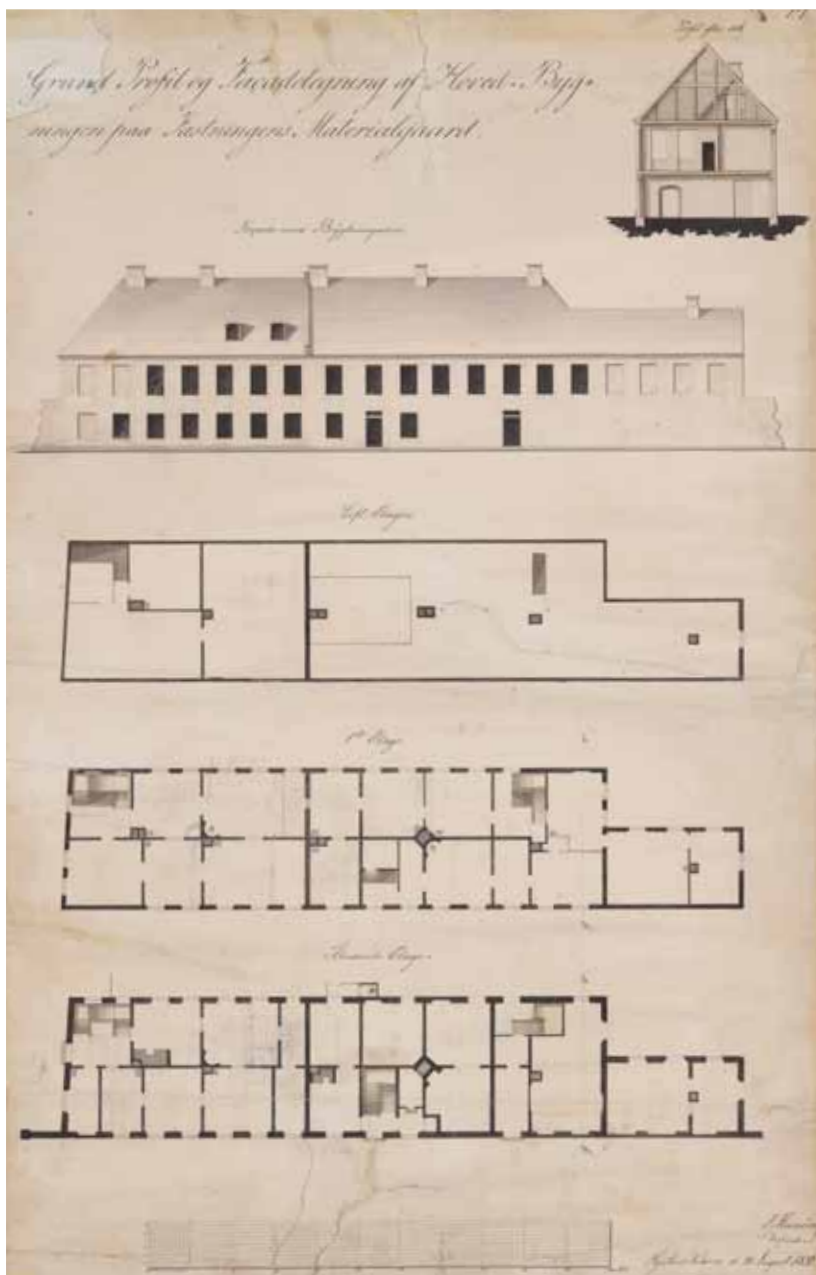
*En mærkelig tilbygning føjedes til nordøstgavlen i 1818.*

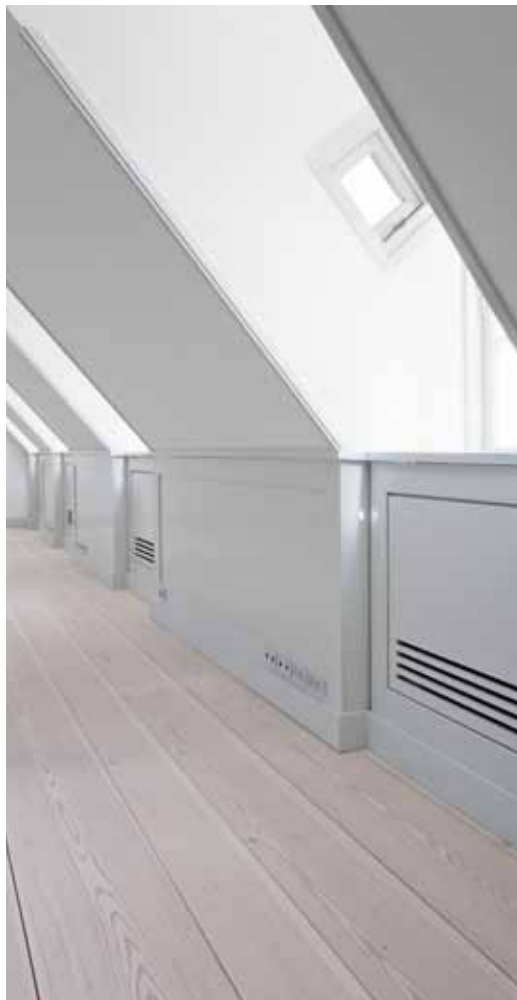
*Magasinbygningen er udvidet tre gange – sidst i 1889.*

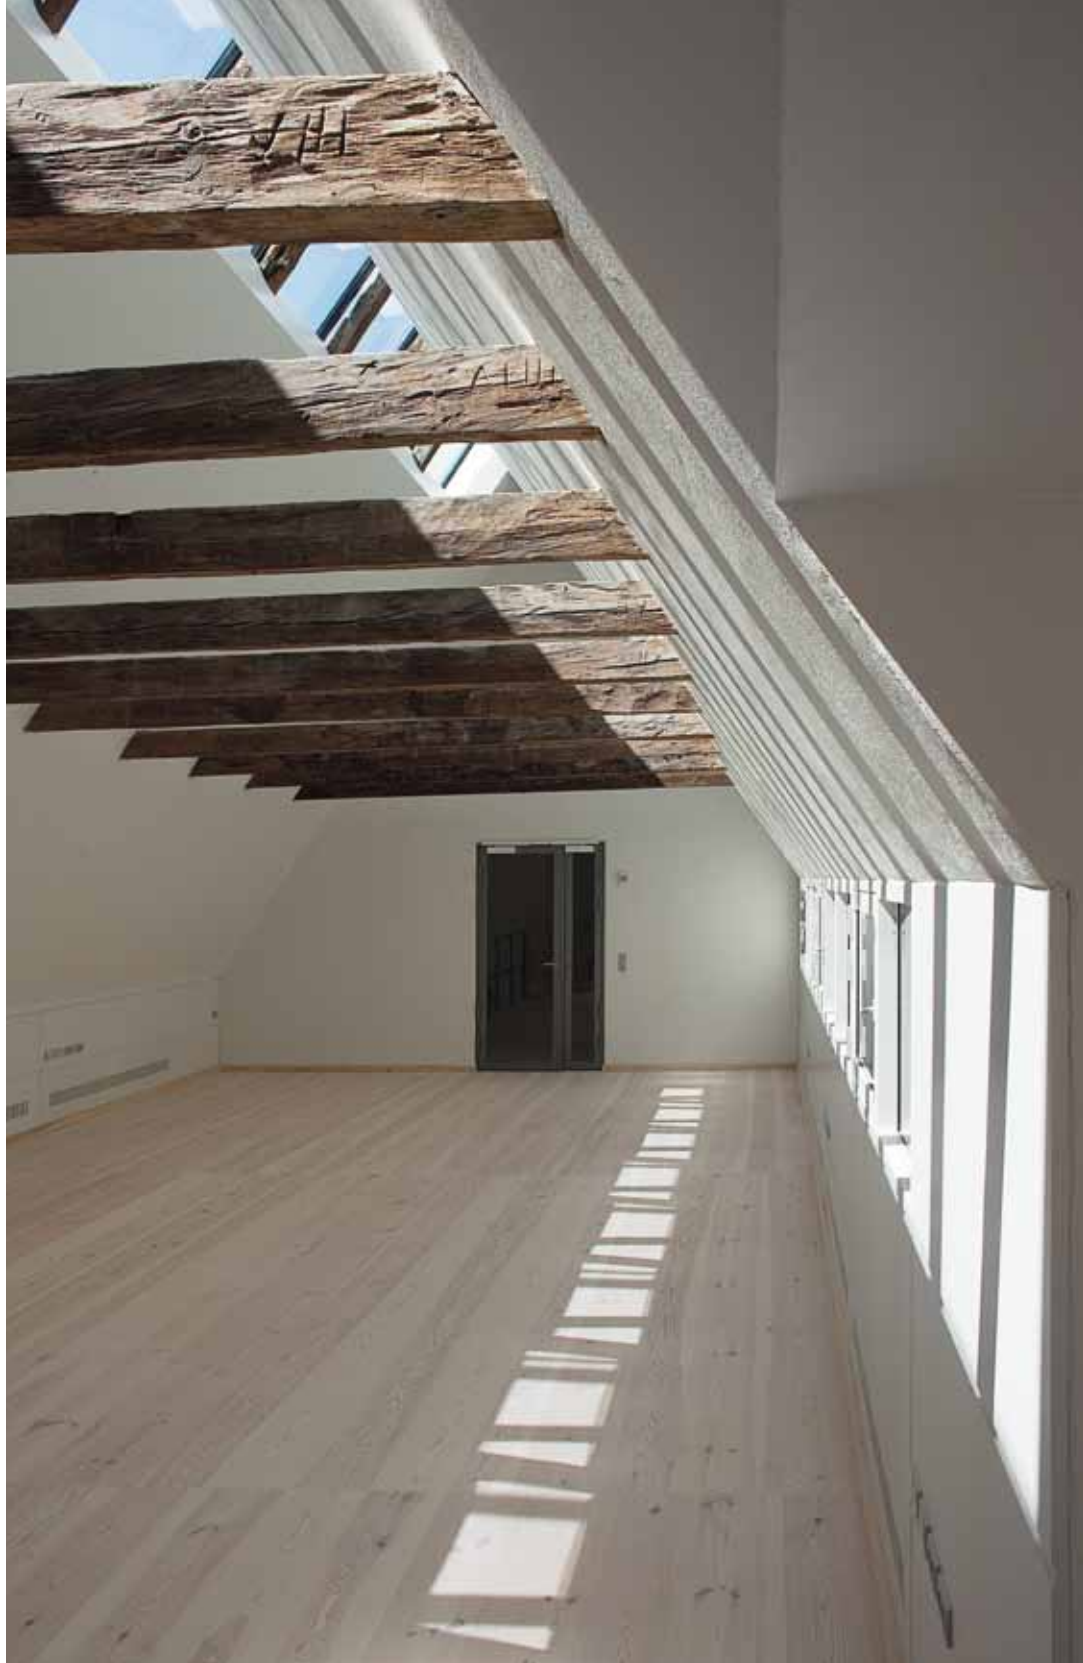
*I Bindingsværkbygningen  
er konstruktionen nu igen  
delvist synlig.*

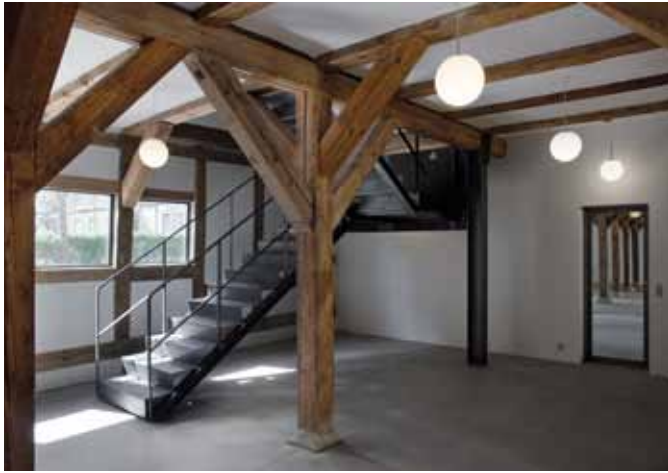
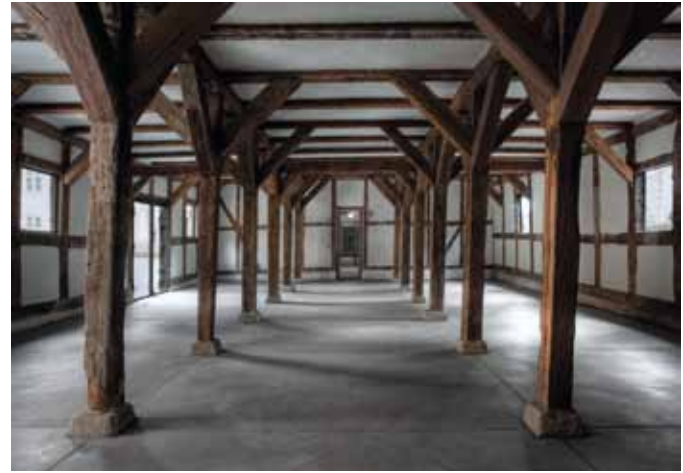
*The structure of the  
Half-timbered Building  
is again partly visible.*

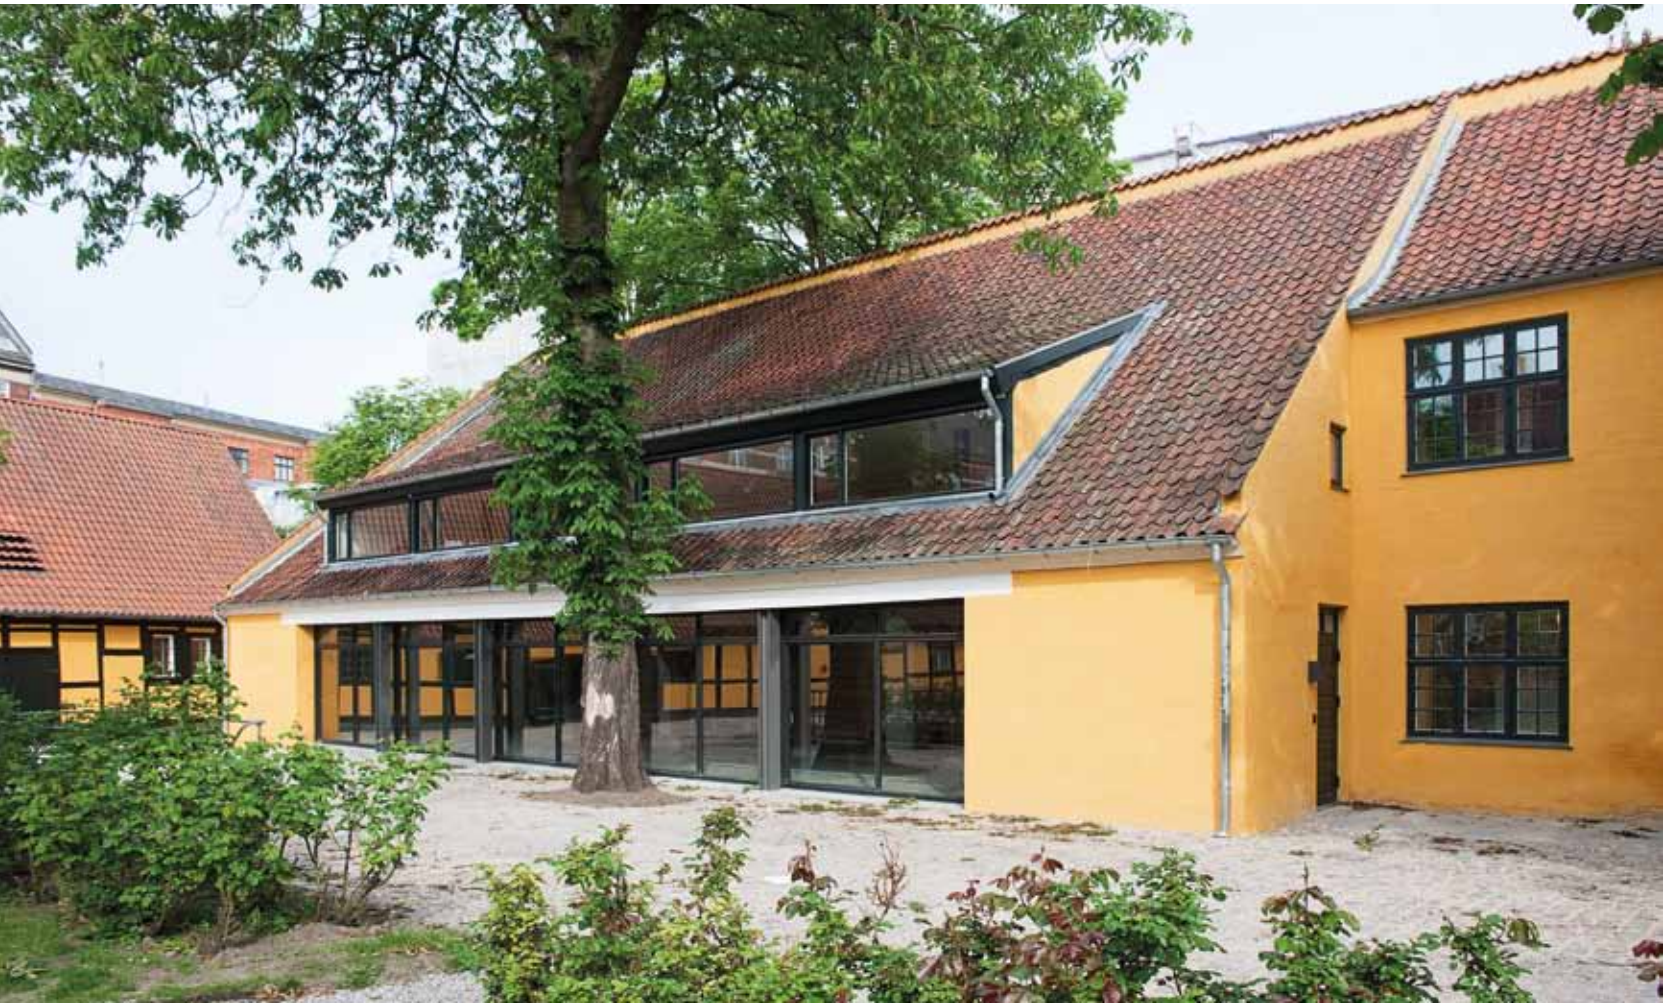
*The brick shed  
was completely open on  
the courtyard.*

Det grundmurede materialskur var mod gården ganske åbent. Mellem to korte murvinger var der en 16,5 m bred åbning, med stolper opdelt i fem dele. Stolperne havde kopbånd sideværts og bar en svær rem. Den er bevaret og er et imponerende stykke tømmer, ca. 17,5 m langt med et tværsnit på 11"x11". De fem åbninger var efter en gammel tegning at dømme uden porte. Omtrent midt i bygningen var der underslag med seks stolper og fire kopbånd pr. stolpe. Tagrummet har man kunnet belaste med

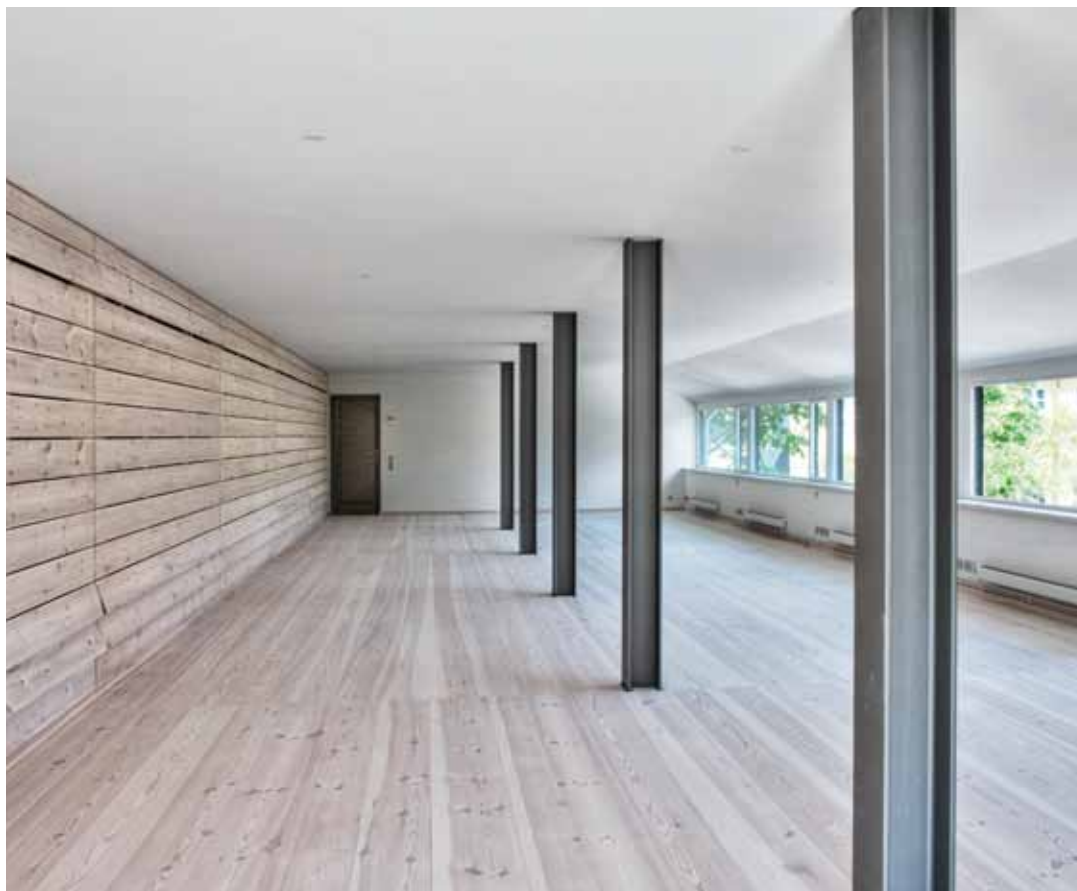
*The back wall with lye-treated wooden planks hides all the building's vertical piping.*

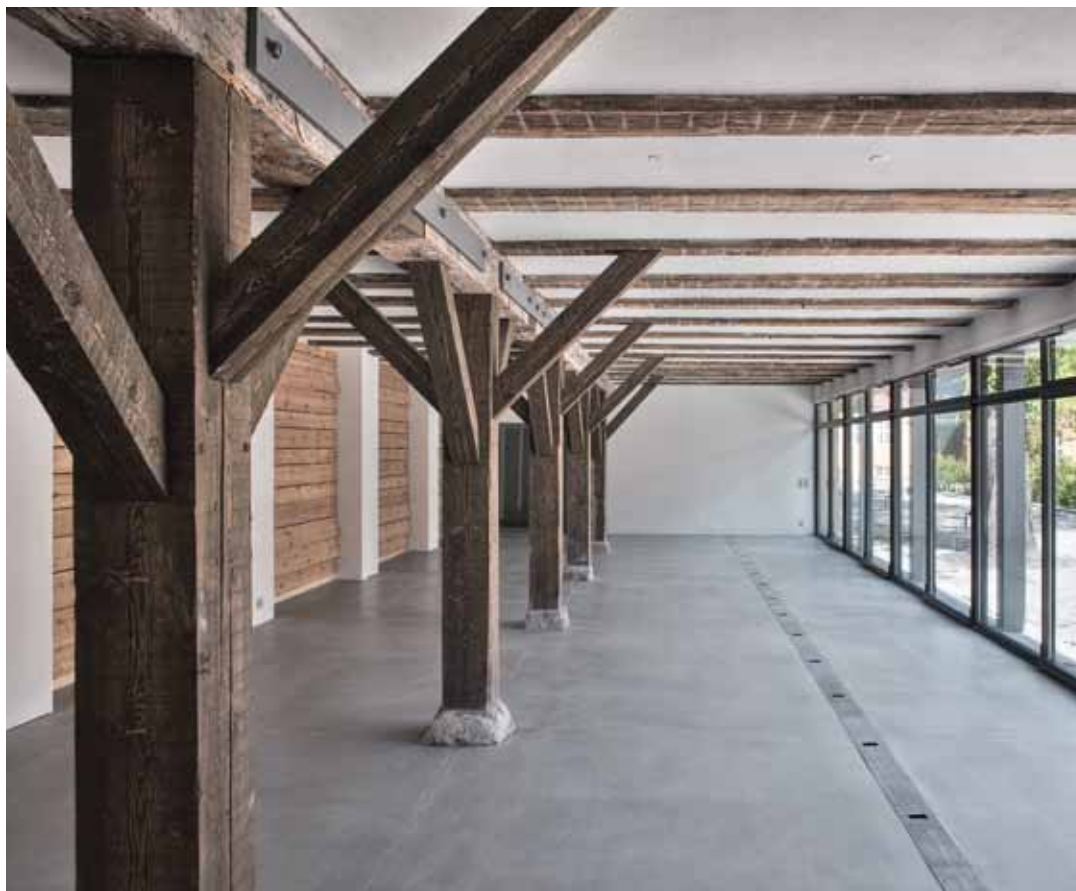
*Istandsættelsesprojektet har taget udgangspunkt i de tre bygningers oprindelige udseende.*

*The restoration project was based on the three buildings' original appearance.*

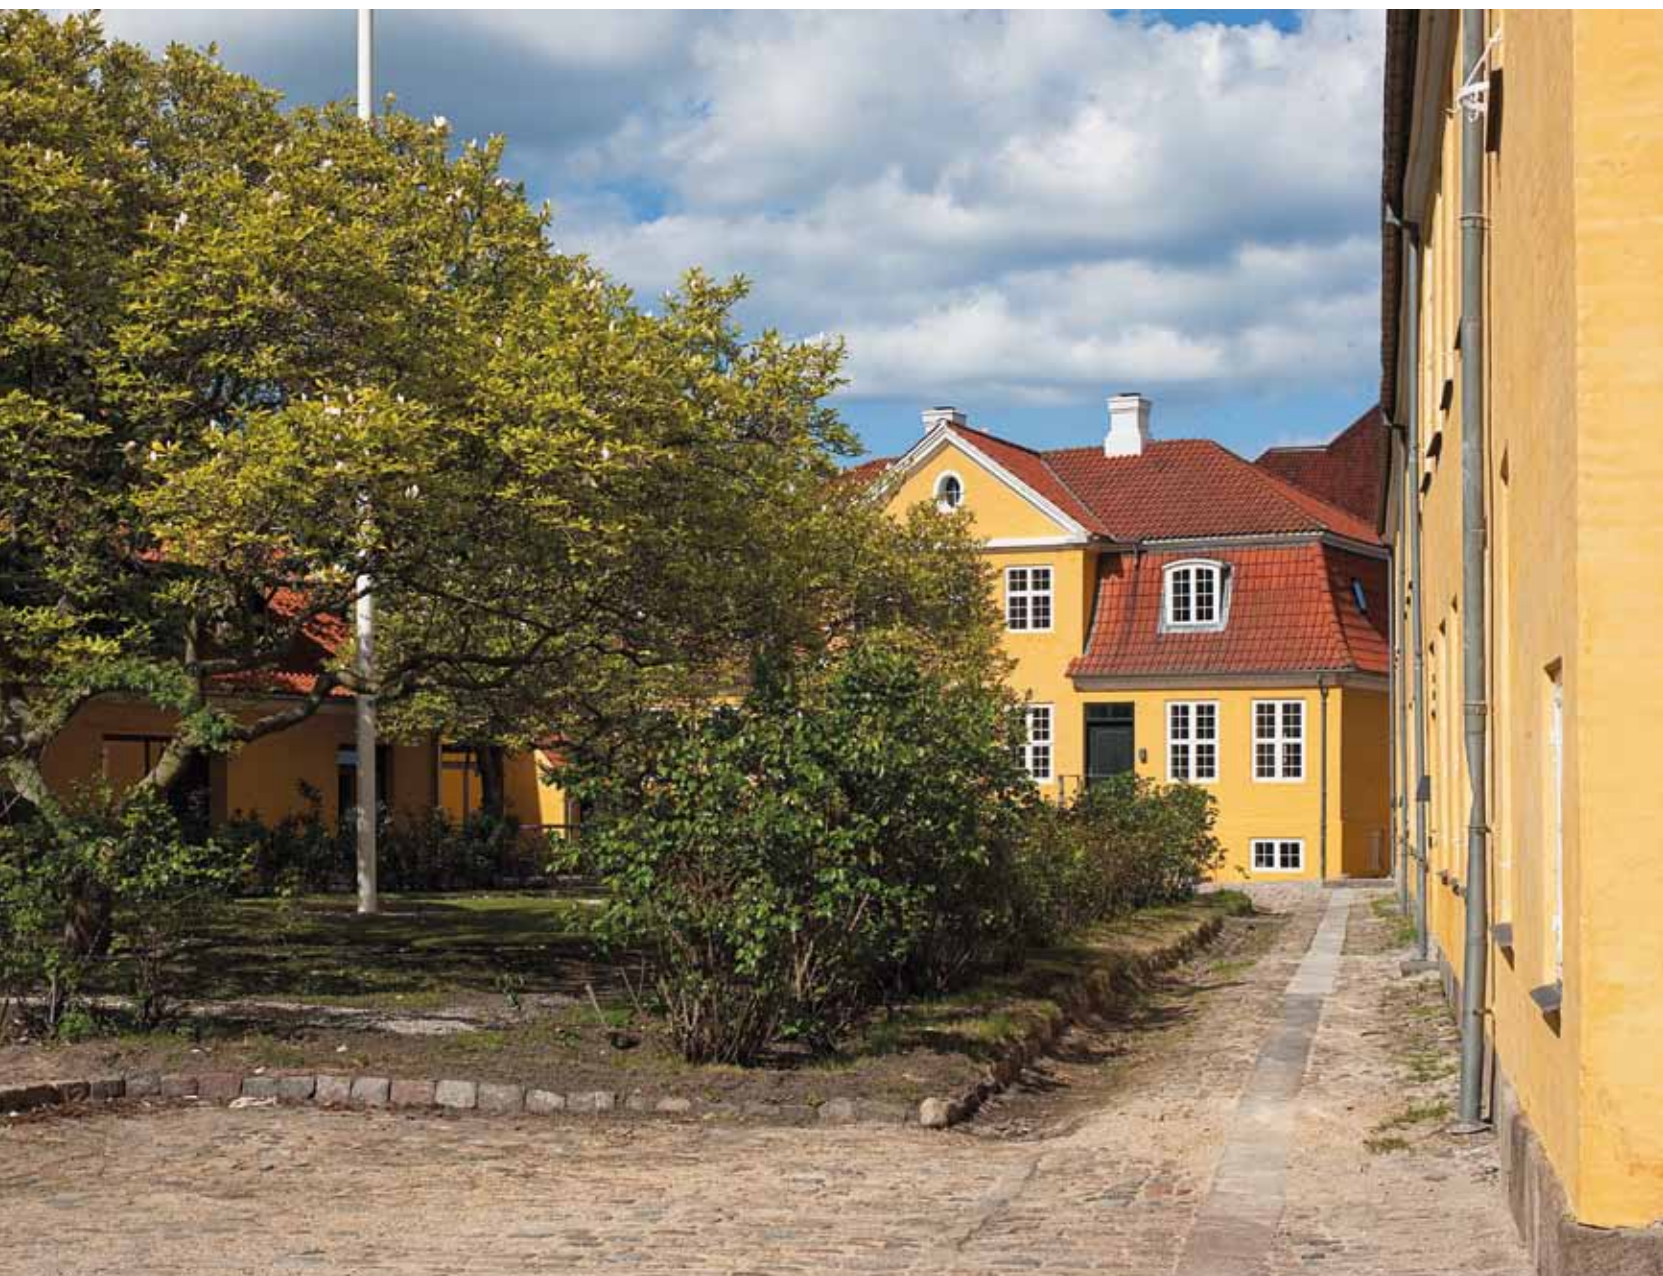
*Modsatte side:  
Destruktive undersøgelser  
konkluderede, at de fire  
bygninger fra begyndelsen  
havde haft meget forskellige  
funktioner og arkitektur.*

*Opposite page:  
Destructive studies  
concluded that the four  
buildings had originally  
had very different functions  
and architecture.*

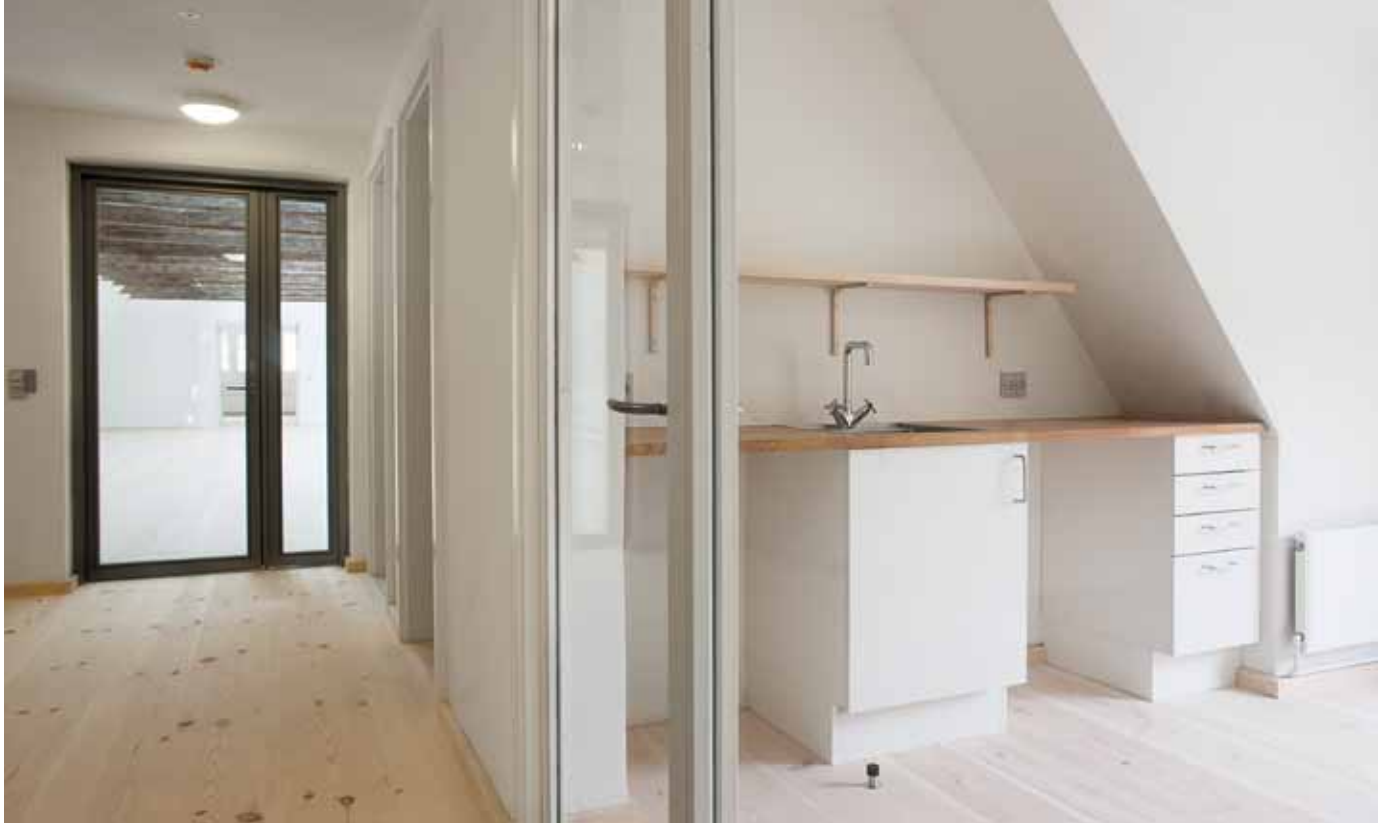
*Resultatet af de grundige energiberegninger viste, at det ville være muligt at opnå CO<sub>2</sub>-besparelser på næsten 20 procent.*

blev de energiforslag, der var anbefalet til videre behandling, beregnet i forhold til potentialet for energibesparelse, simpel tilbagebetalingstid og CO<sub>2</sub>-besparelse. Det udgjorde grundlaget for andet vurderingsmøde, som resulterede i indkredsningen af en nettoliste med beskrivelser af, hvordan det enkelte energibesparende tiltag kunne udføres, og hvilken effekt det ville have i forhold til besparende effekt i energimængde, indeklimamæssig effekt, netto CO<sub>2</sub>-besparelse og simpel tilbagebetalingstid, ud fra nuværende energipriser.

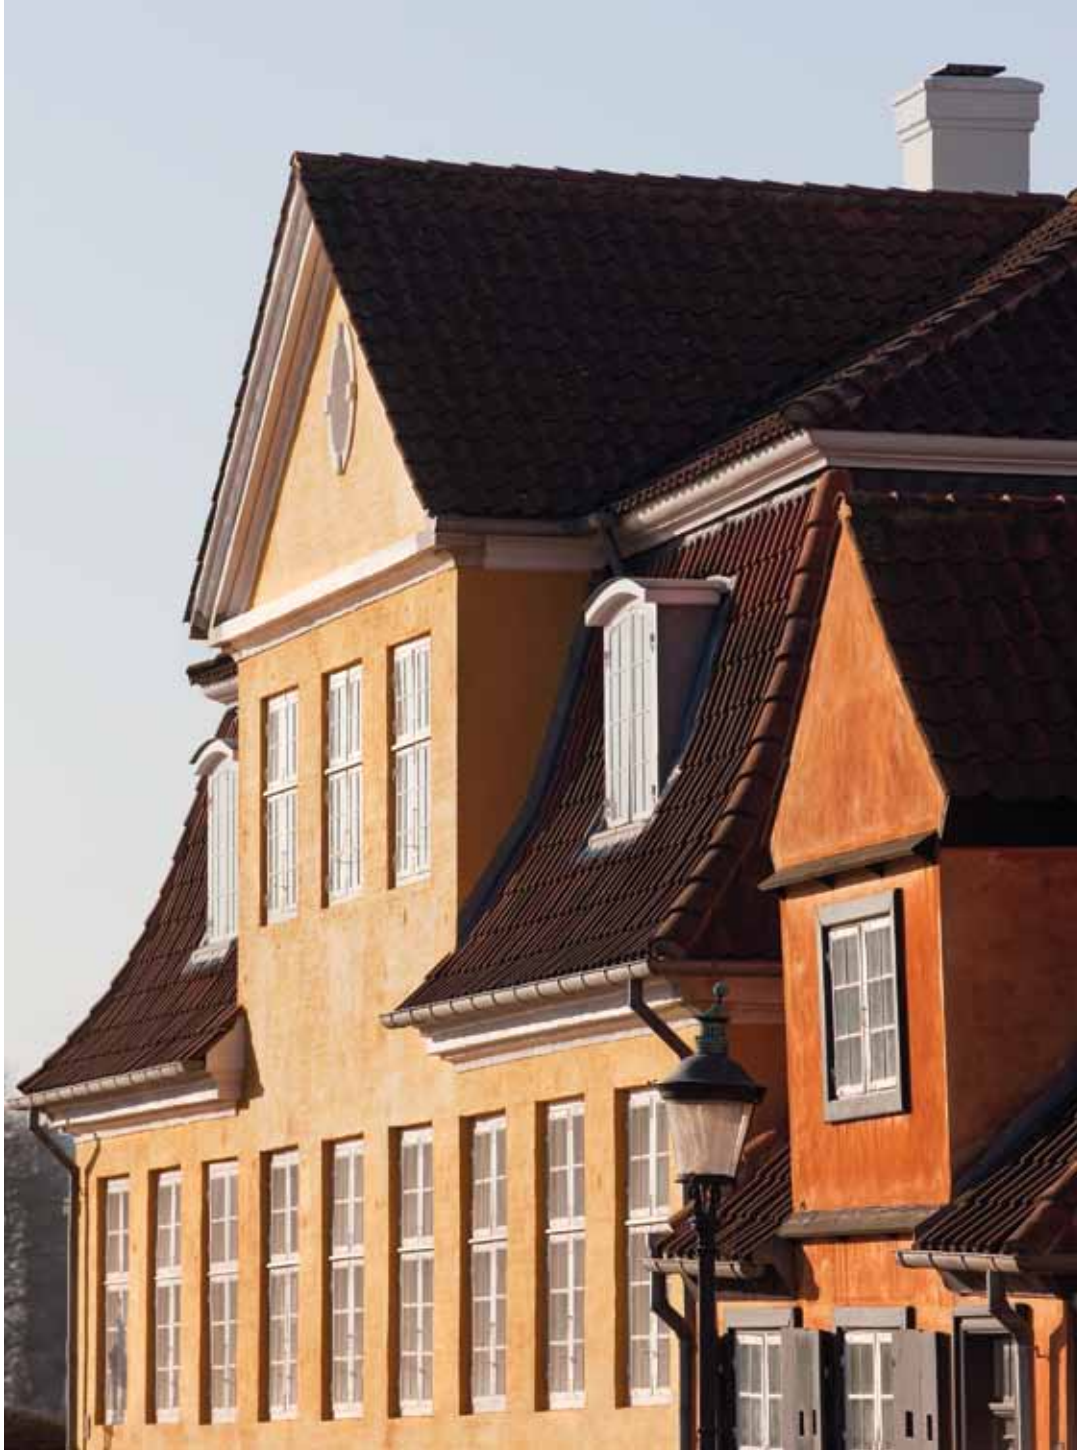
*Materialforvalterboligen er opført ud mod Frederiksholms Kanal som en grundmuret bygning med gulkalkede facader og et rødt tag.*

*The Superintendent's Residence was built along Frederiksholms Kanal as a brick structure with yellow, limewashed facades under a red-tile roof.*

nine bays long, with yellow, limewashed facades under a red-tile roof. The building has one story above a high basement as well as a high mansard story in the roof, embellished with three-bay, pedimented front gables on the street and the courtyard. The high plinth raises the building above street level and differentiates it from the other buildings in the Fortifications Depot, emphasizing its special significance in the complex. It originally housed the Superintendent, but was also used for official functions, something that is reflected in the different stories' clear hierarchy. The ground floor's richly decorated rooms, large and small, faced the street and canal. The second story formed the private sphere, and the basement served practical needs.

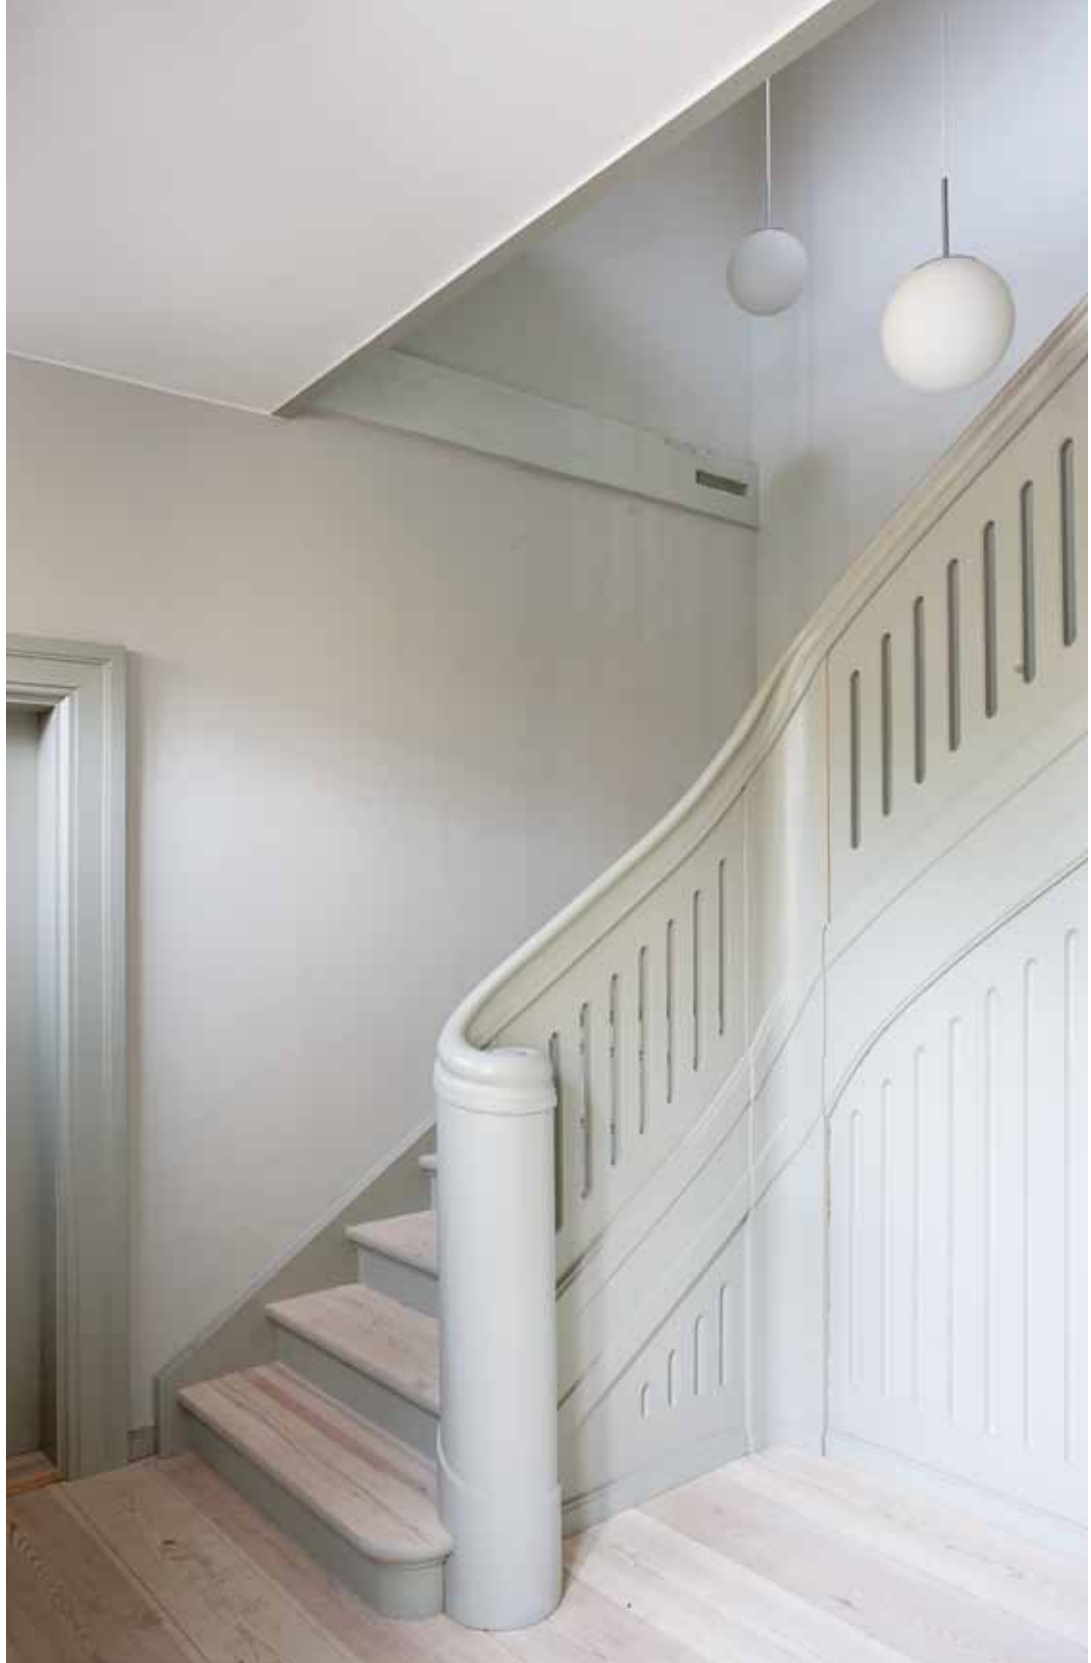
*The old staircase was  
demolished and replaced  
by a new one. This one  
gives better circulation  
on the stories.*

to the second story. At the very top was a half staircase, which ended curiously in a blank wall. The staircase's location in the second and third bays from the east end wall moreover made it impossible to make a round of all the rooms on the story. This is why the staircase was demolished and replaced by a new one, although the old one had some cultural-historical value, if not antiquarian. In the overall picture, architectural and functional assessments outweighed it.

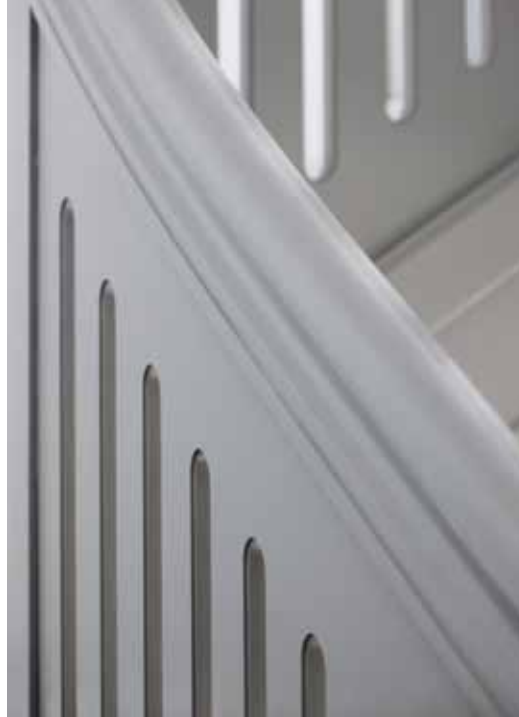
*Den nye trappe respekterer husets ånd og er derfor opført som en trætrappe med fine snedkerdetaljer og profileringer*

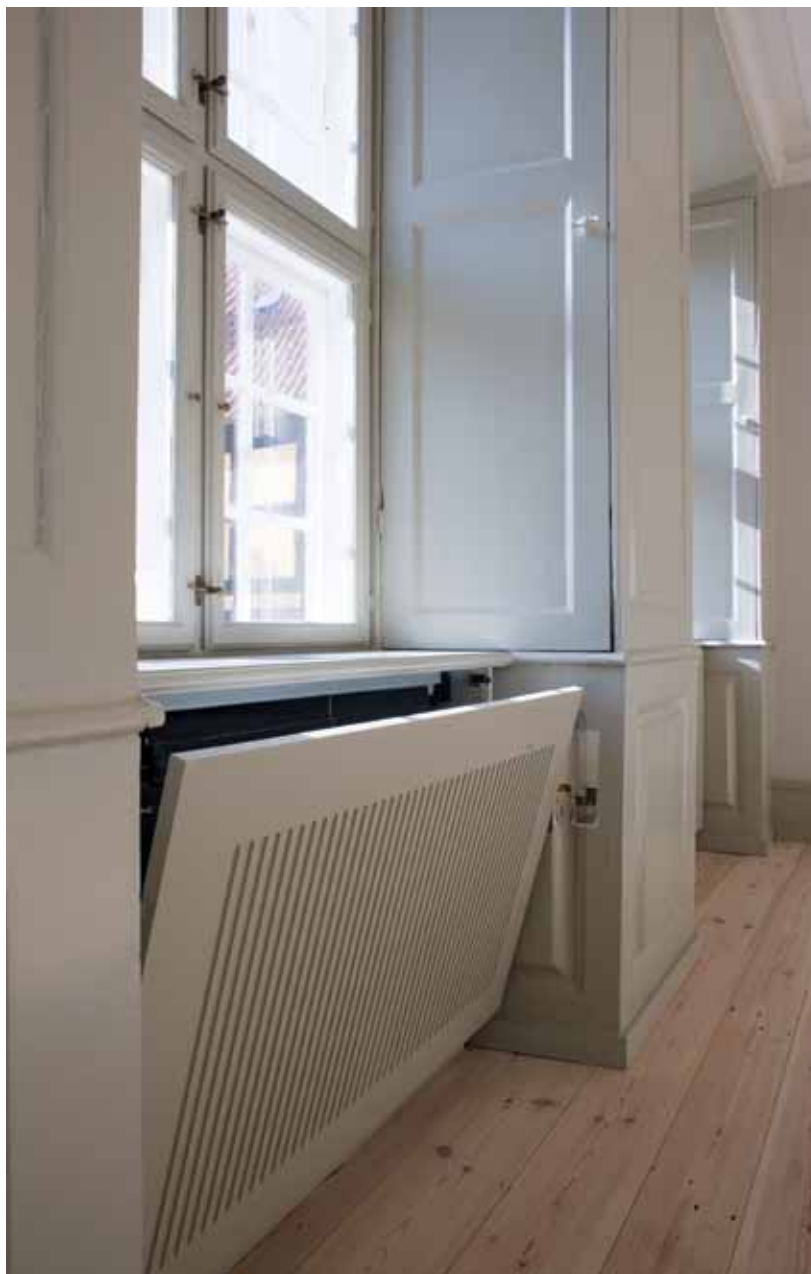
*Glasset i den yderste vinduesramme har et særligt spil af ujævnheder, der har stor arkitektonisk og fredningsmæssig værdi.*

The second major energy-saving measure in the Superintendent's Residence was replacing the panes in the secondary windows with low-E glass. It was unfeasible to replace the glass in the outer window frames because the imperfections in the old glass give a distinctive play of light that has great architectural and heritage value for the building as a whole. Since this quality cannot be recreated in insulating or low-E glass, the group chose to concentrate its efforts on the secondary windows. One of the challenges was to find glass with a maximum thickness of 3 mm to fit the dimensions of the frames. A great deal of effort was also spent finding glass with low iron content so that it did not have a green tint. The glass that was chosen has a slightly grayish coating inside

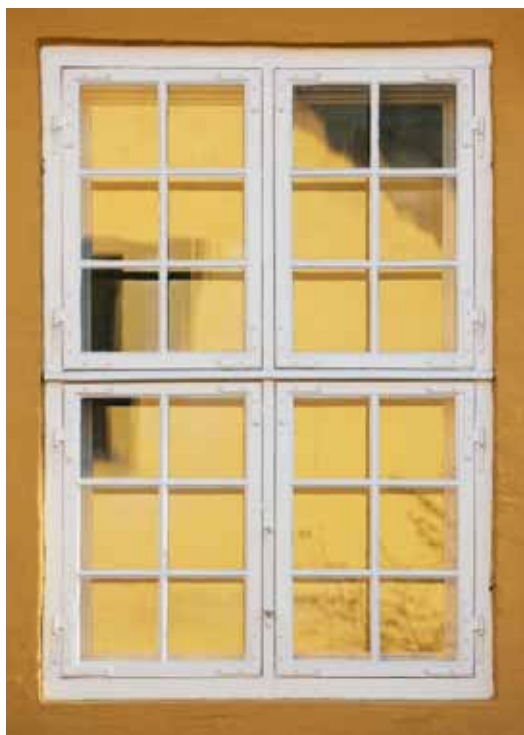
*The glass in the outer window frames has a distinctive play of light that has great architectural and heritage value.*
