# Fæstningens Materialgård

Udgivet af Realdania Byg

Fæstningens Materialgård  
The Fortifications Depot

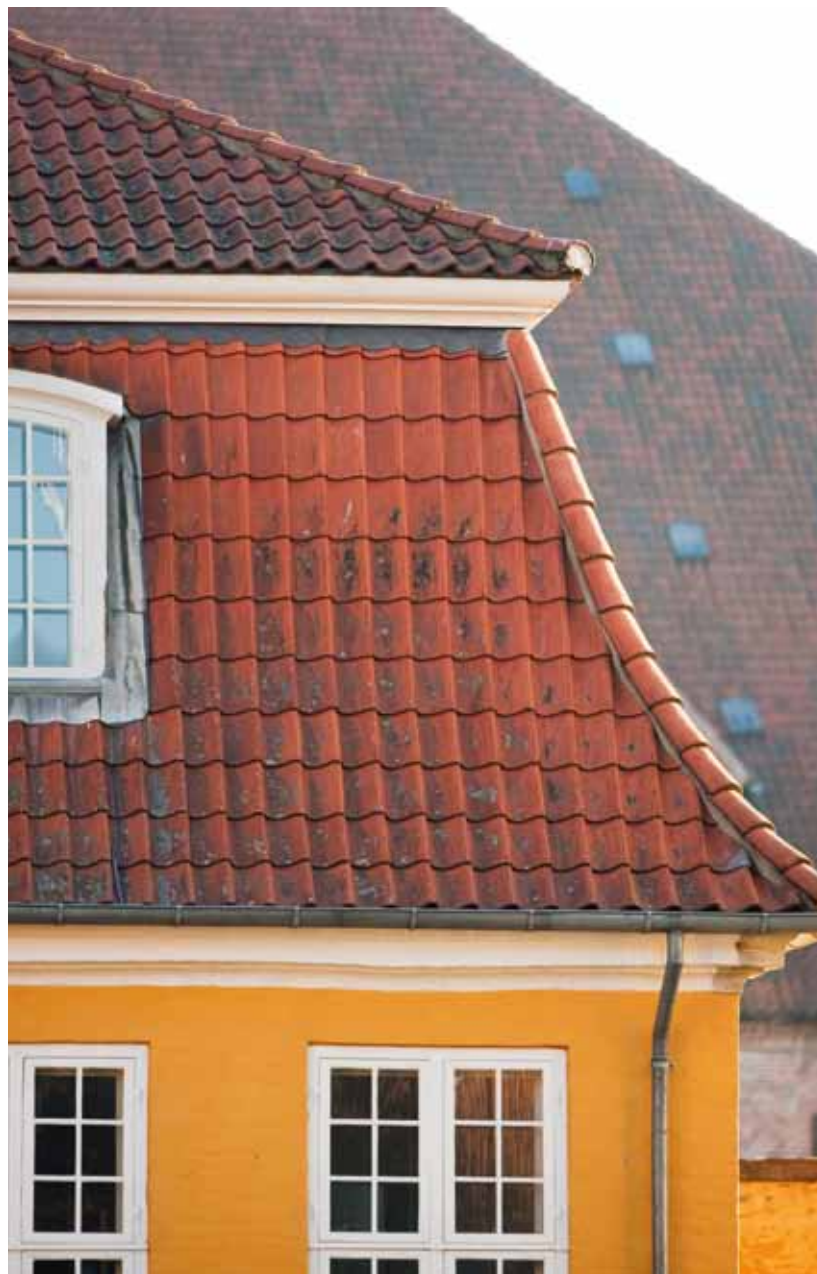
*Samlet forventes bygningen at nå en relativ CO<sub>2</sub>-reduktion på 6 procent.*

*As a whole, the Superintendent's Residence is expected to achieve a relative CO<sub>2</sub> reduction of 6 percent.*

Når bygningen tages i brug forventes det, at energiglasset vil give en CO<sub>2</sub>-reduktion på 4,29 procent, mens den øgede tæthed af klimaskærmen vil resultere i en reduktion på 6,11 procent. Centralstyring af strømforbruget vil medføre en CO<sub>2</sub>-reduktion på 7,50 procent, men behovet for køling vil samtidig indvirke negativt med 0,47 procent på CO<sub>2</sub>-besparelsen. Samlet forventes bygningen at nå en relativ CO<sub>2</sub>-reduktion på 6 procent i forhold til CO<sub>2</sub>-udledningen fra Materialforvalterboligen inden energirenoveringen.

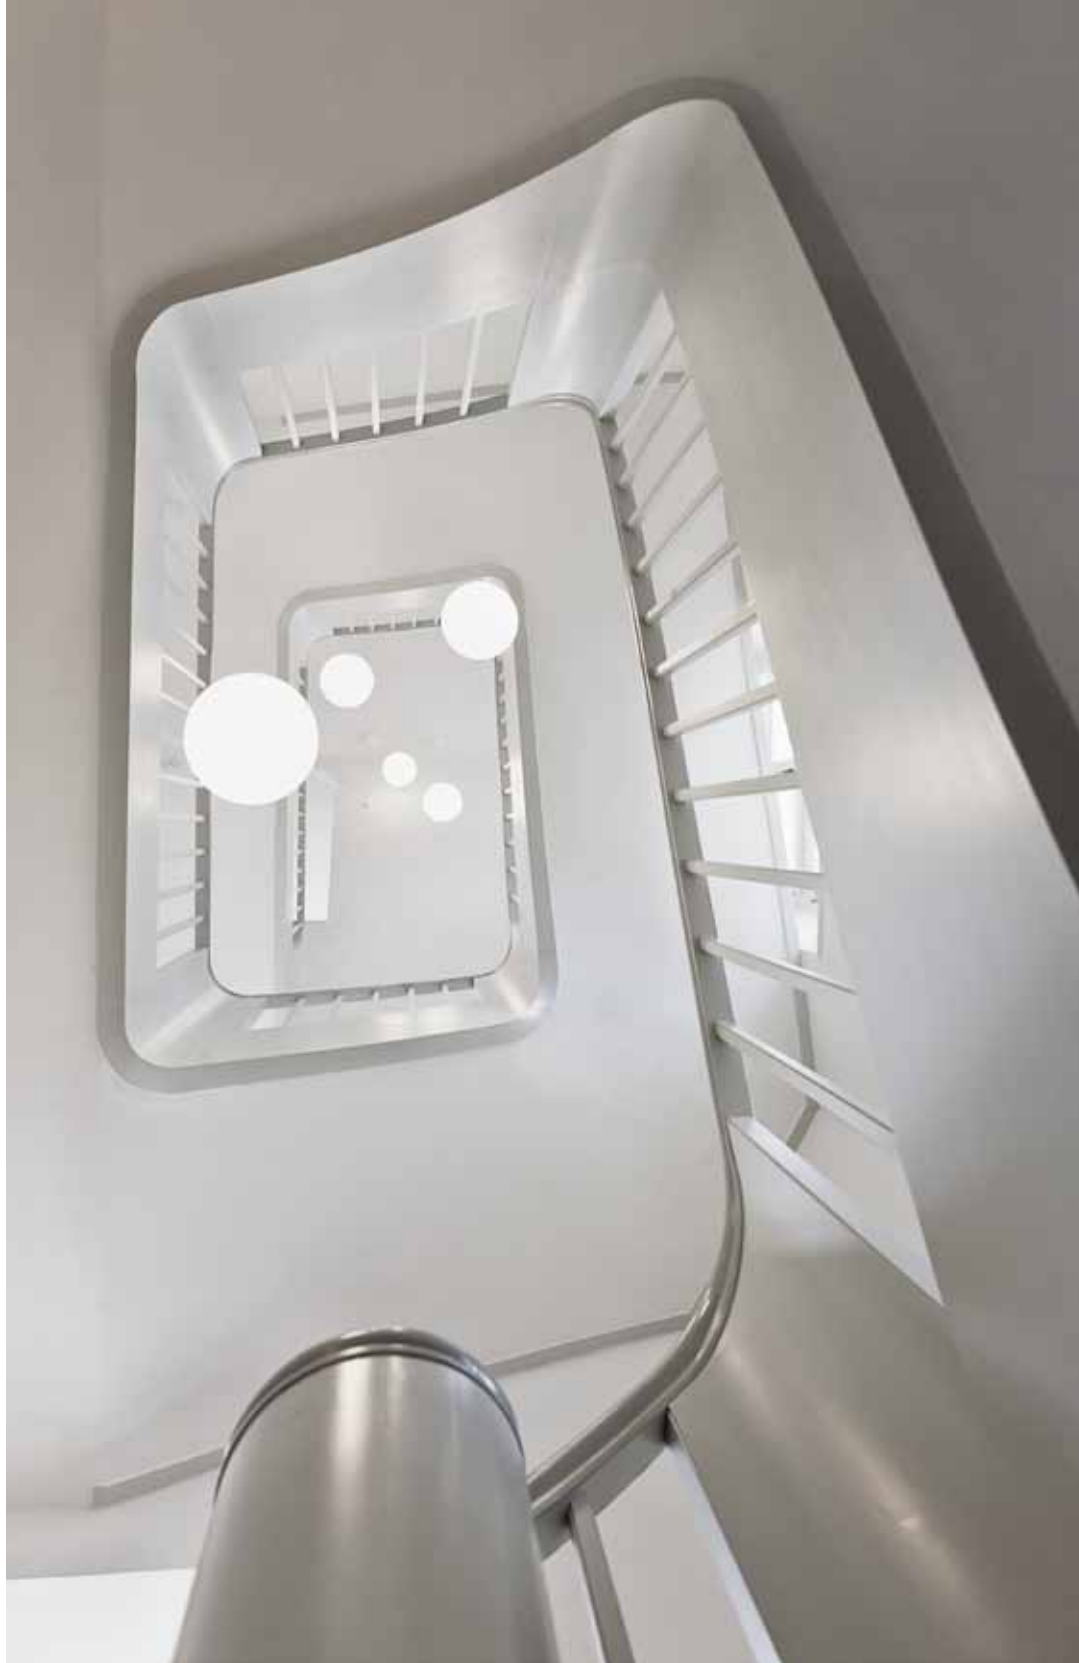
*I det oprindelige portfag mod nord er trappen flyttet fra midten af bygningskroppen til det nordøstlige hjørne og opført som en ny halvsvingstrappe.*

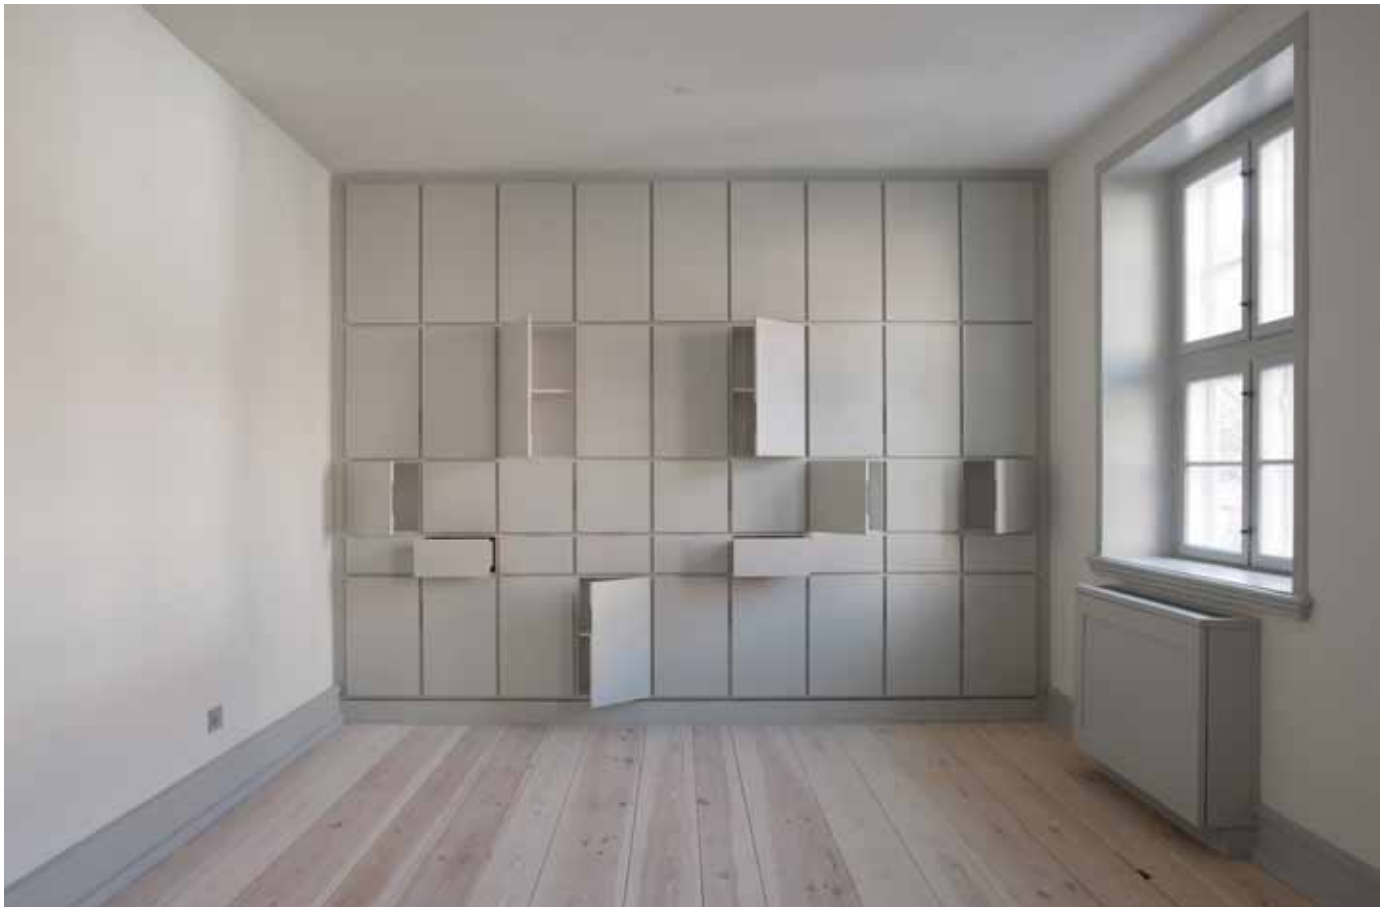
*Hele bagvæggen i receptionen udgøres af en skabsvæg, der lidt muntert kaldes 'julekalenderen'.*

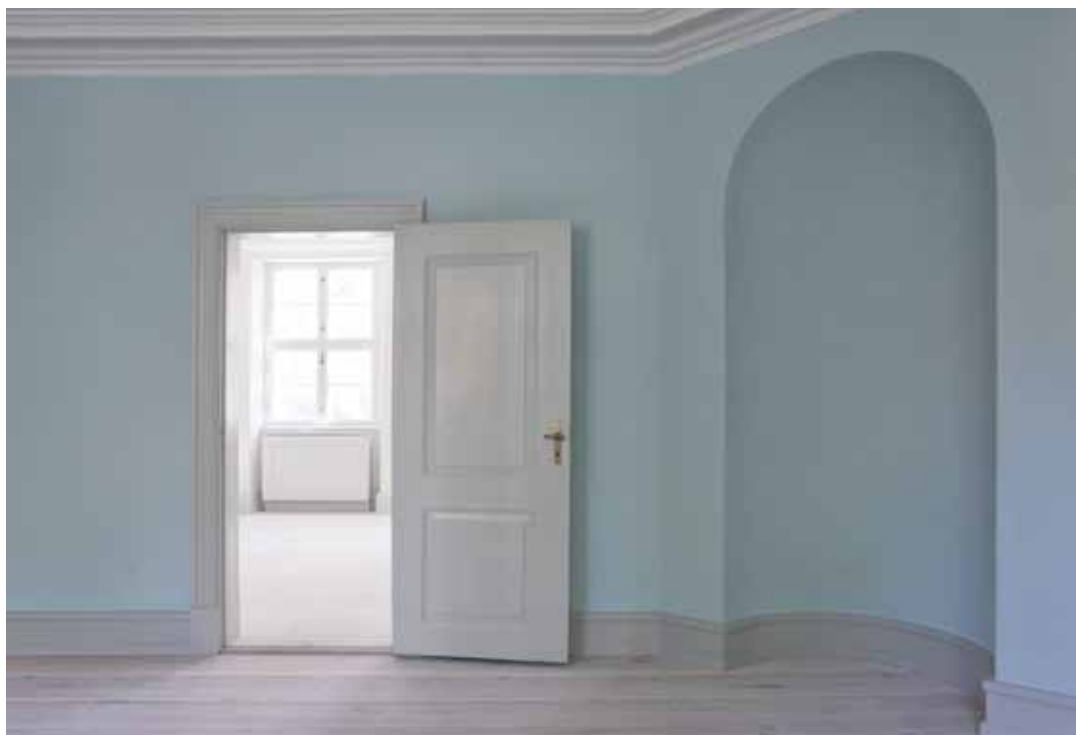
*Her har man ikke fundet farvemæssige inspirationskilder at gå ud fra. I stedet har arkitekterne valgt en palet med 12 nuancer af kølige og varme farver.*

*No sources of inspiration were found here for the colors. Instead, the architects chose a palette of 12 nuances of cool and warm tones.*

In contrast to the Superintendent's Residence, no sources of inspiration were found here for the colors that could be used on the Magazine's walls. Instead, the architects chose a palette of 12 nuances of cool and warm tones that were test-painted on large sheets of cardboard and placed in the rooms so they could be evaluated on the site. The colors range from gray, bluish-green, and golden to baby-pink nuances. The strongest colors are used in rooms with circulation and through traffic, with more subdued

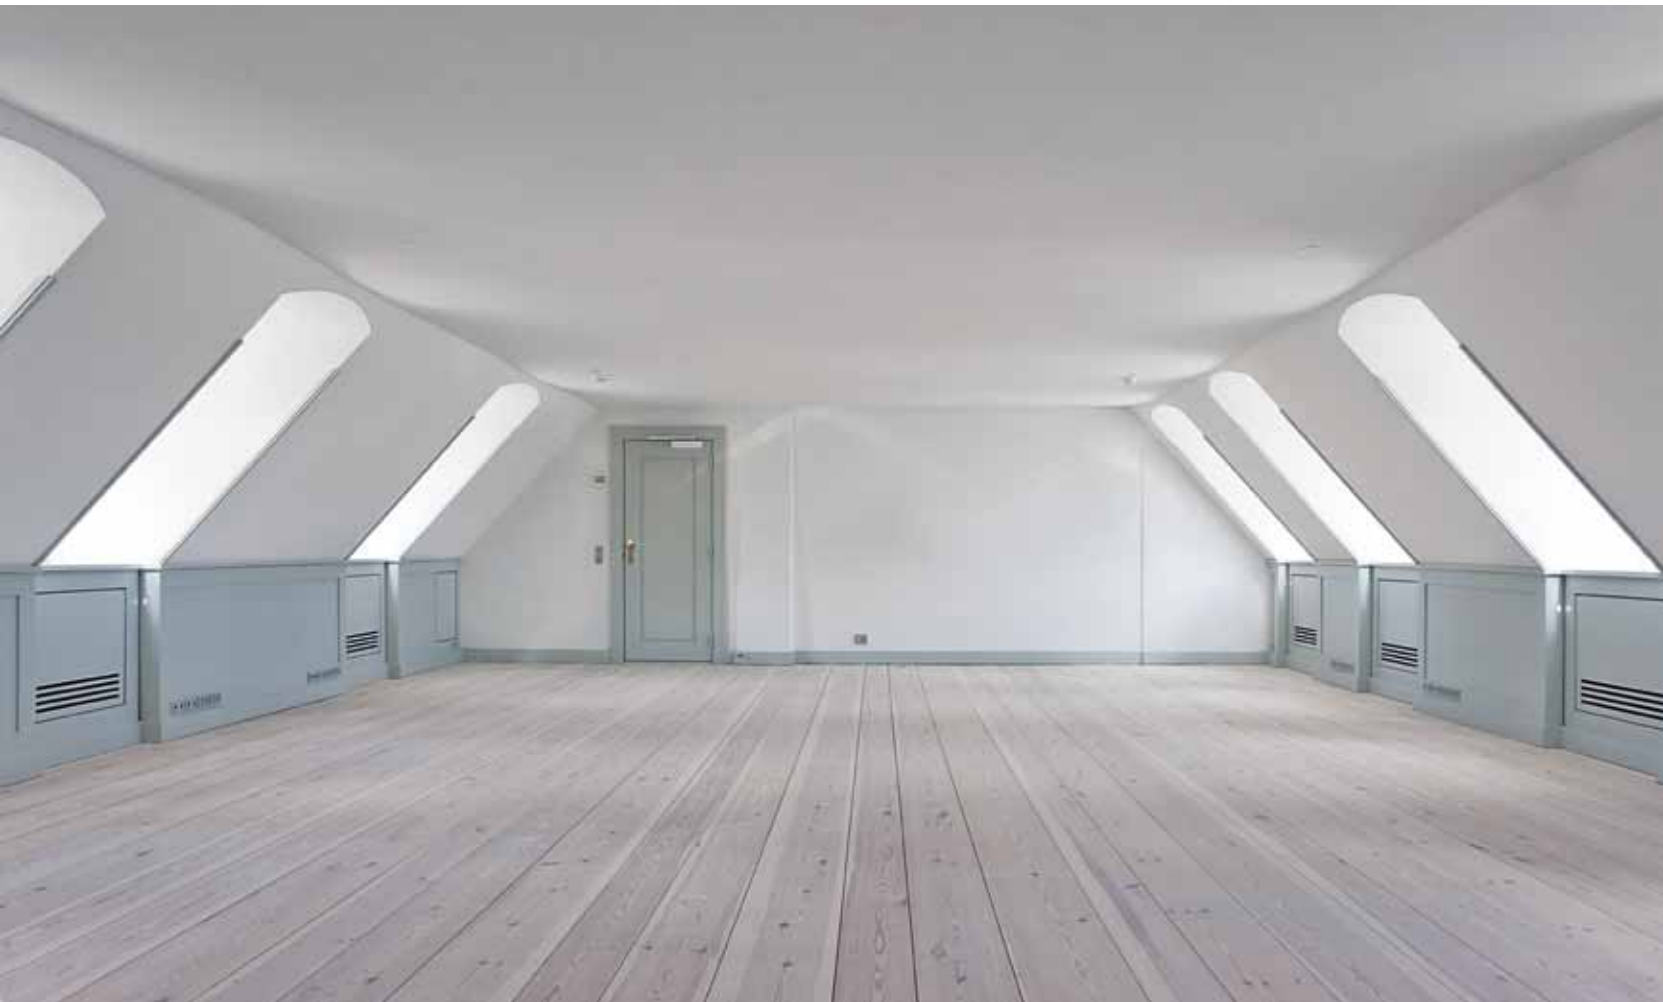
*Bag det sobre ydre gemmer der sig uendelige mængder moderne teknologi og kilometervis af kabler.*

*Behind the sober exterior lie an infinite quantity of modern technological equipment and kilometers of cables.*

The cables that link all this technological hardware are state-of-the-art signal cables that presumably have a long life, though not as long as the pine floors above these thick bunches of wiring. This naturally gave rise to many lengthy deliberations about whether it

was right to fill old heritage buildings with high-tech components that require both vertical and horizontal cable-tray systems for which there actually is no room in the building's structure. The components have to be hidden, work impeccably for years, and yet still be accessible for service if they do not. This challenge was met by laying the greatest number of cables under the floorboards, which

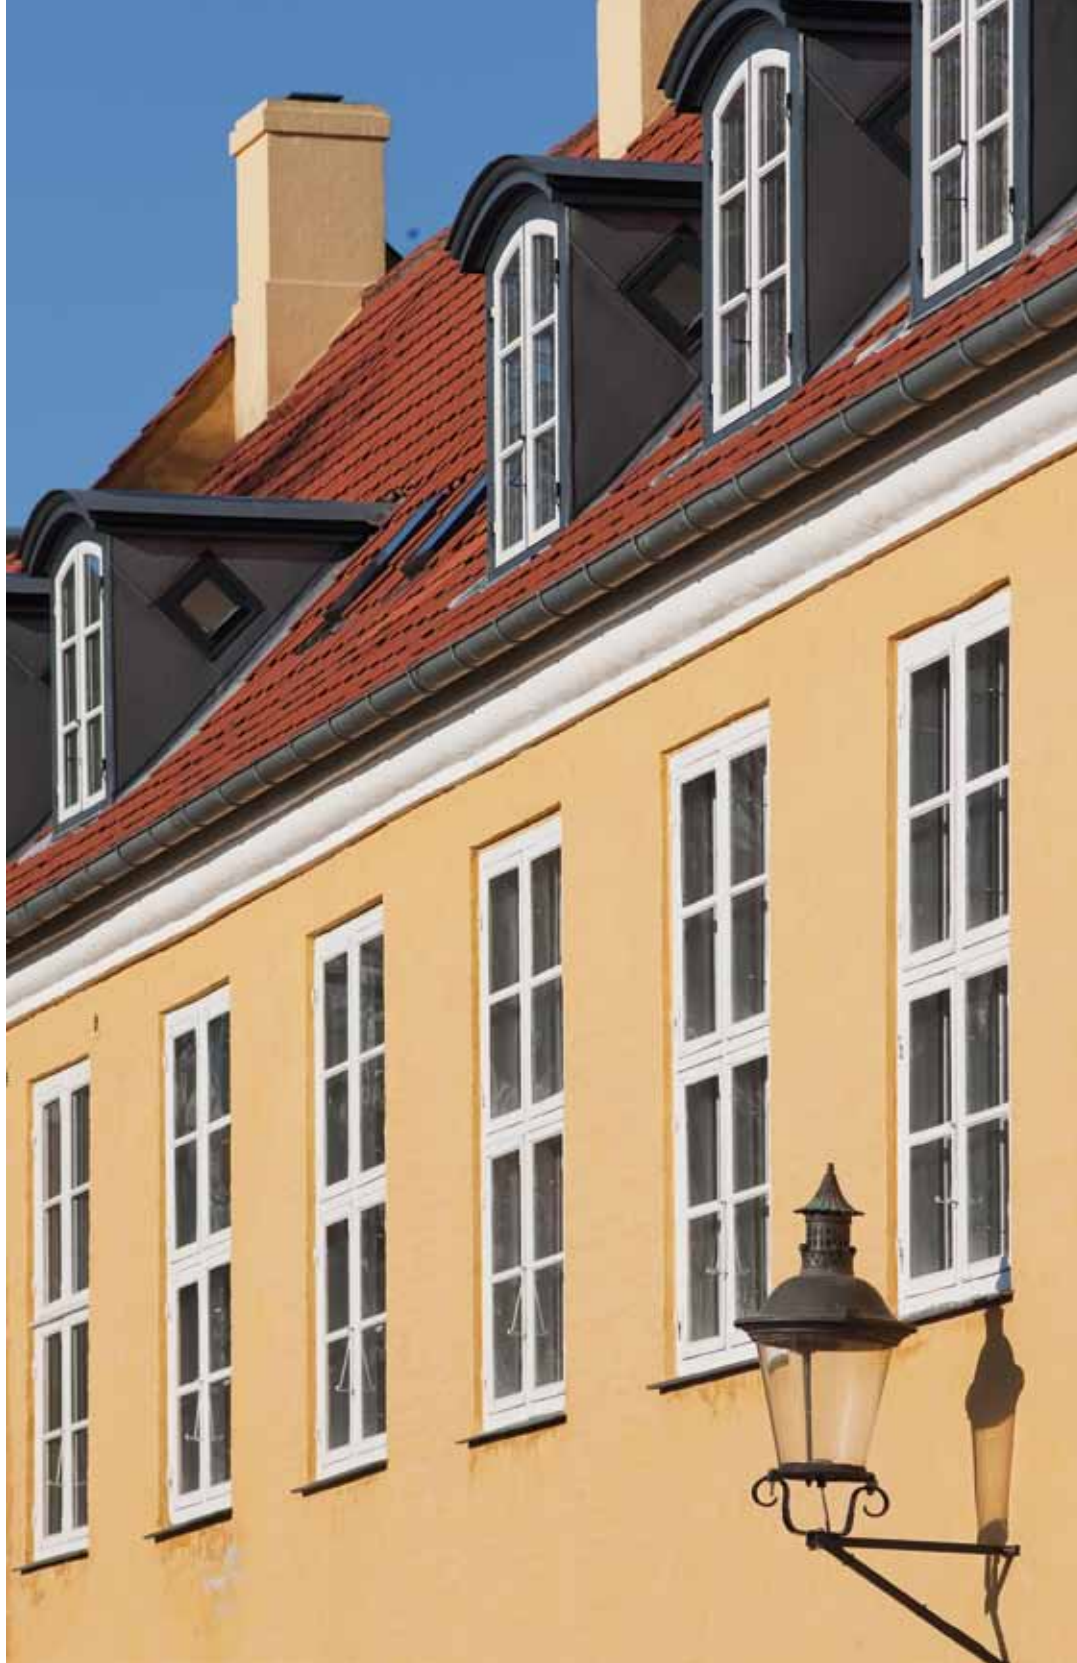
*Bygningen består i dag af  
18 fag, som står med  
gulvaskede facader i to  
etager under et rødt tegltag  
med høj rejsning.*

*Today the building consists  
of 18 bays, with yellow,  
limewashed facades under  
a high-pitched red-tile roof.*

The oldest part of the Magazine on Bryghusgade dates to 1768. Since then, it has been lengthened twice and its interior has been remodeled several times. Today it consists of 18 bays, with yellow, limewashed facades under a high-pitched red-tile roof. The roof surface is broken by a party-wall parapet, which denotes one of the remodeling stages, and by an irregular pattern of dormers and skylights on both the street and the courtyard. One of the building's distinctive characteristics is its very low plinth, a detail that shows it was originally used as a warehouse that needed direct and more or less horizontal access to the stores. Because of the many extensions and remodelings, the Magazine is a spacious and complex structure, but also one with rooms of spatial and structural values and fine details from several periods that it is important to uncover and highlight.

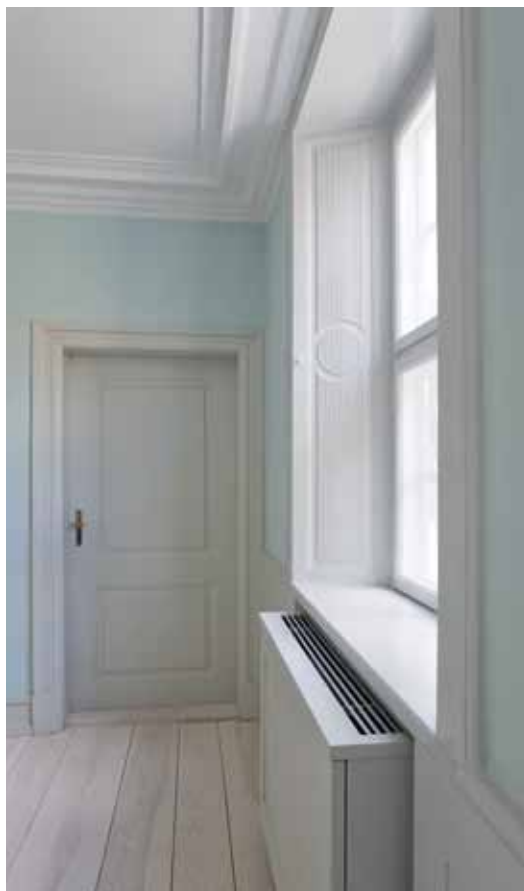
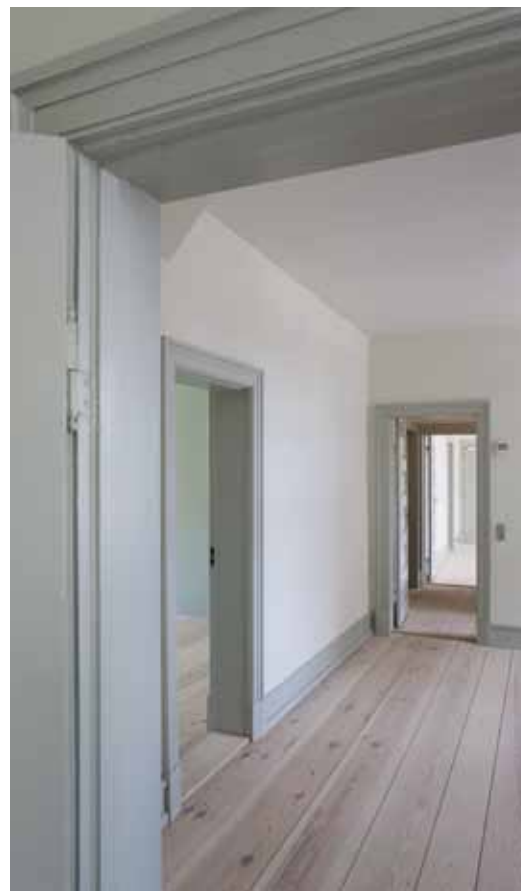
*I forhold til bygningens oprindelige tilstand er den forventede CO<sub>2</sub>-reduktion på 20 procent, samtidig med at det er muligt at opnå et termisk indeklimaniveau svarende til klasse C.*

*The expected CO<sub>2</sub> reduction in comparison with the building's original state is 20 percent, while it is possible to achieve a thermal indoor climate level corresponding to class C.*

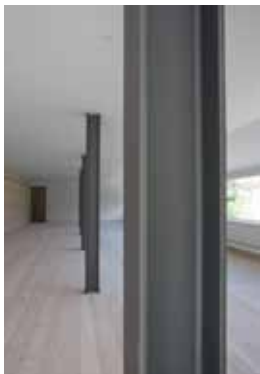
*Modsatte side:  
Tømmerkonstruktionerne udgør en af de bærende bevaringsværdier i Halvtagshusene, mens de øvrige værdier knytter sig til selve bygningens udformning.*

*Opposite page:  
The timberwork comprises one of the Shed Building's primary heritage values, while the others are its design.*

*Materialerne i Halvtags-husene er generelt enkle og prunkløse; her er ingen stuklofter eller forfinede snedkerdetaljer.*

*The materials used in the Shed Building as a whole are simple and unostentatious. There are no stuccoed ceilings or refined carpentry.*

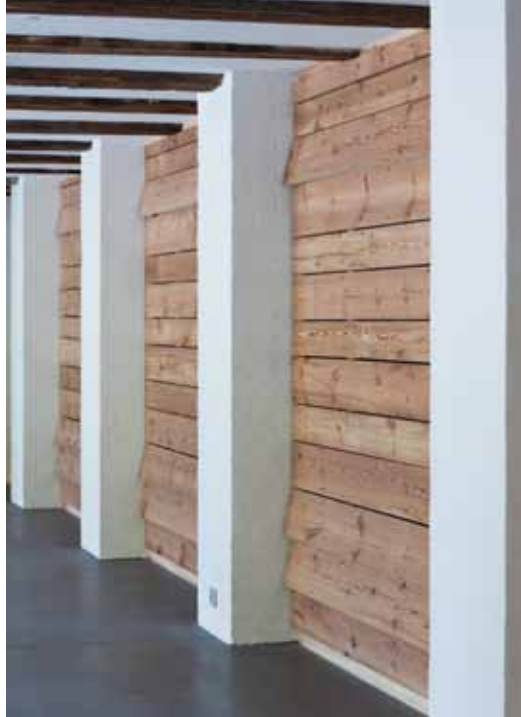
*I forhold til den oprindelige bygning er den forventede CO<sub>2</sub>-reduktion 20 procent og samtidig opnås et termisk indeklimaniveau svarende til klasse C.*

*The expected CO<sub>2</sub> reduction is 20 percent in comparison with the building as it was, and at the same time results in a thermal indoor climate corresponding to class C.*

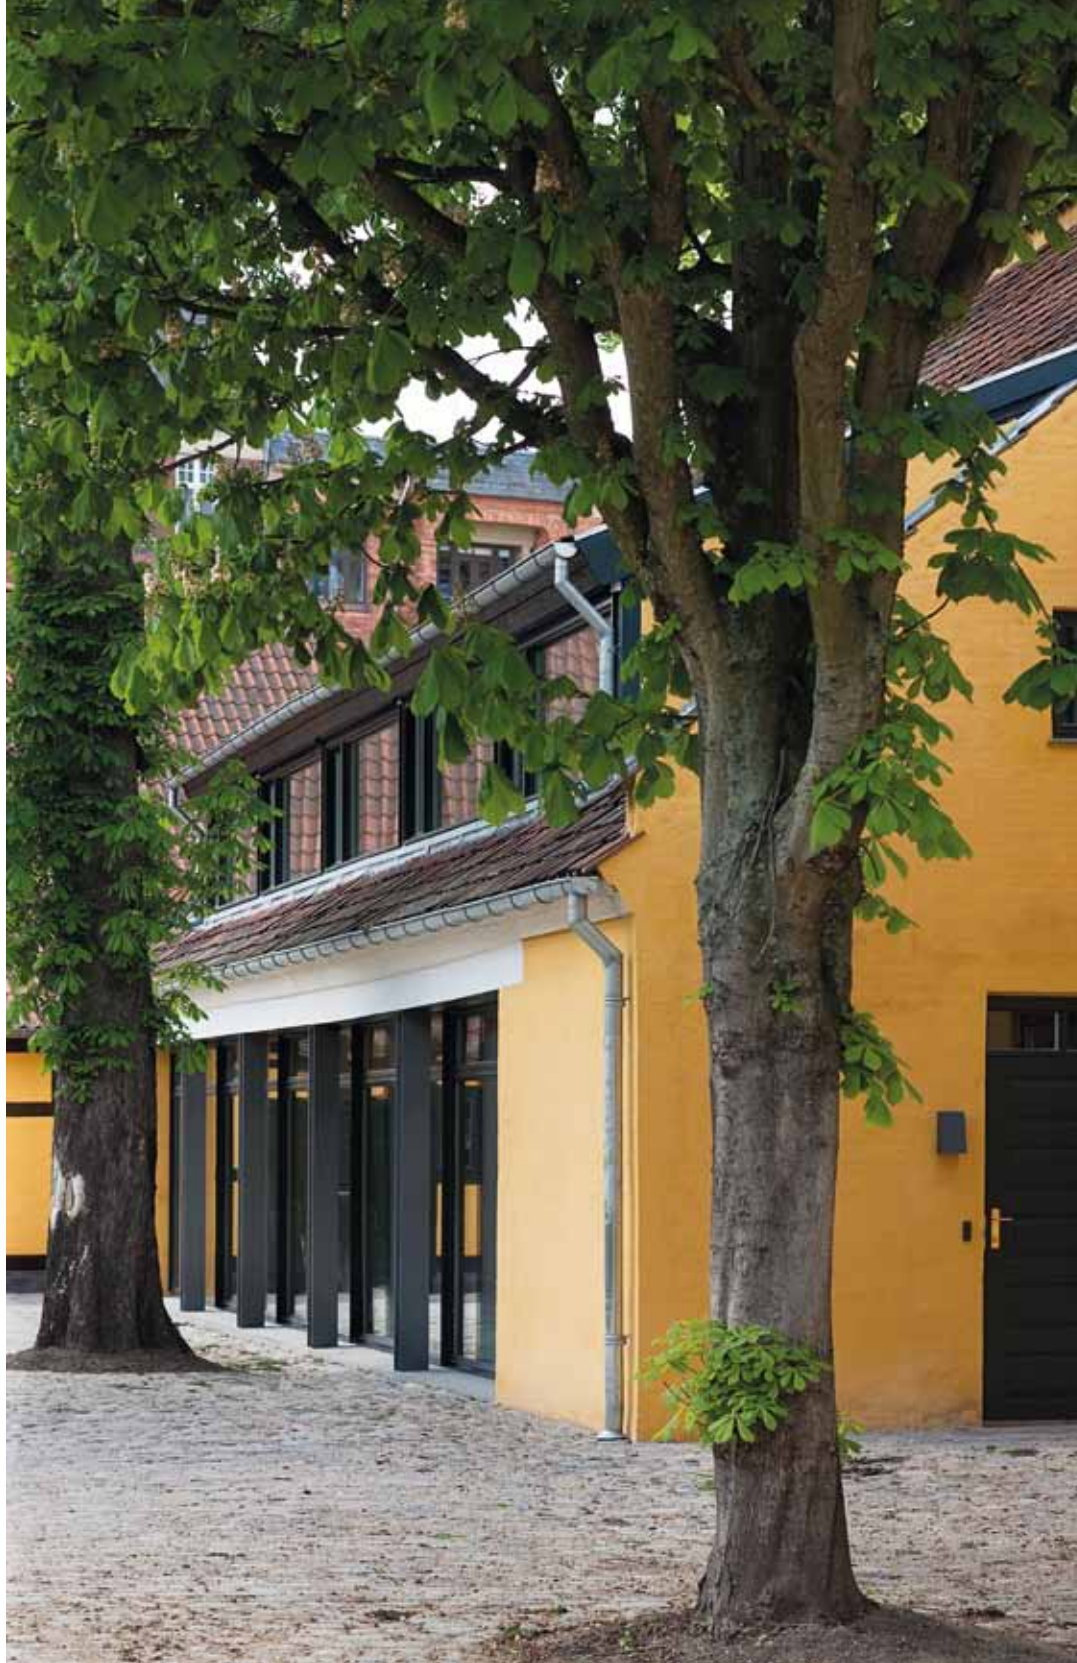
*Hensigten bag restaureringen: At genskabe bygningernes karakteristika som mere eller mindre åbne skure.*

*The intention behind restoration: to recreate the three original buildings' characteristics as more or less open sheds.*

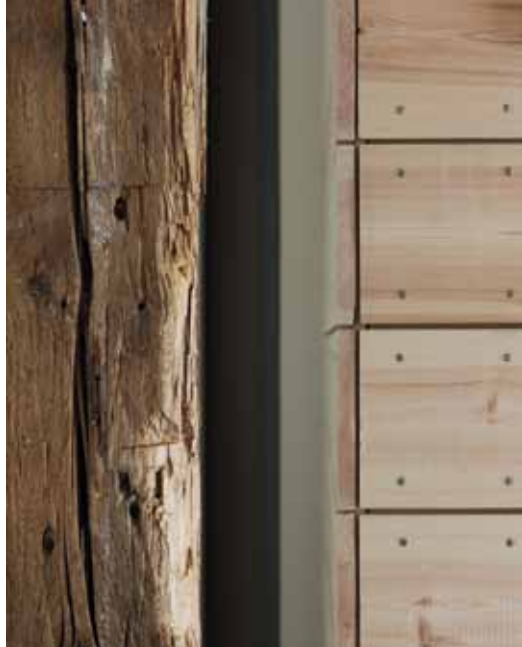
*The ambition was to make the building's structure its distinctive feature.*

This approach led to interesting deliberations about the relationship between old and new. The architects namely proposed that the new posts that were to take the place of the ones that had been removed could be made of steel, so that the changes were understandable and a contrast was created between old and new. The fact that the steel columns could be imbedded in the ground, and thus create the transverse stability that the rather loose-jointed building needed, spoke in favor of this proposal.

The heritage authorities, however, believed that because the building's structure had been highlighted as one of its primary heritage values, it was necessary to remain true to the original structural principle and recreate the missing wooden posts. Their viewpoint gained support in the end when it became obvious that the lunchroom that was to hold the steel columns would end up with five steel columns and nine wooden posts. The overall impression was most important here.

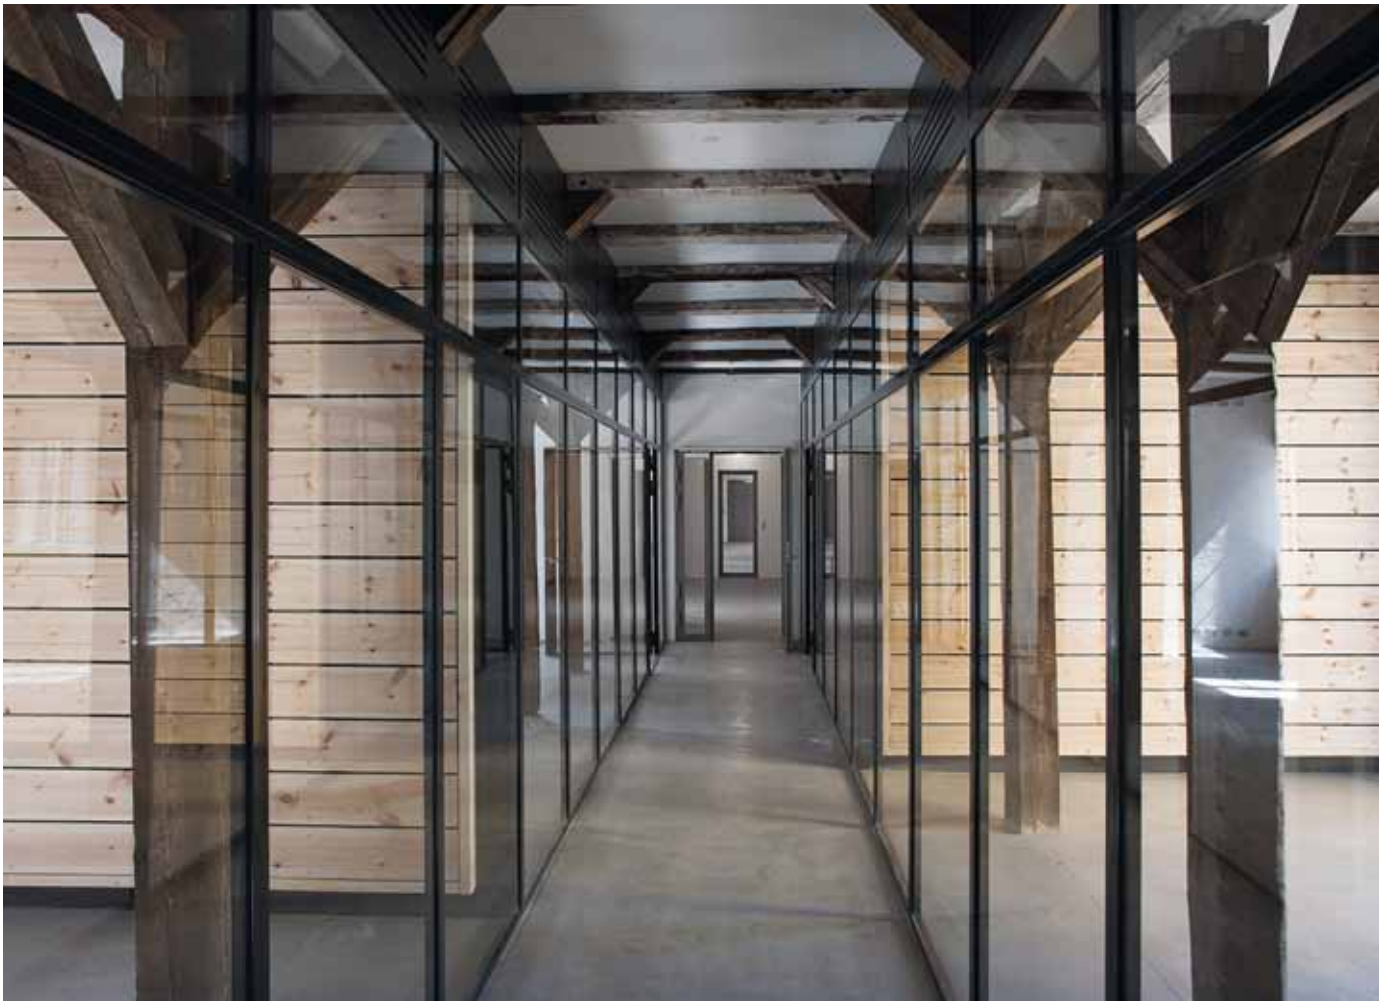
*One of the strokes of genius in the project was the decision to bring together common service facilities under one roof.*

One of the strokes of genius in the entire Fortifications Depot project was the decision to bring together common service facilities, such as the lunchroom and meeting rooms, under one roof instead of apportioning them among the individual buildings. This brings life to the courtyard in the course of the day, when people walk to and from meetings and lunch. Most importantly, combining facilities that require ventilation for short periods but with high efficiency has a positive effect on the CO<sub>2</sub> balance in two ways. First of all, mechanical ventilation does not have to be installed in the buildings with no open offices or common meeting rooms.

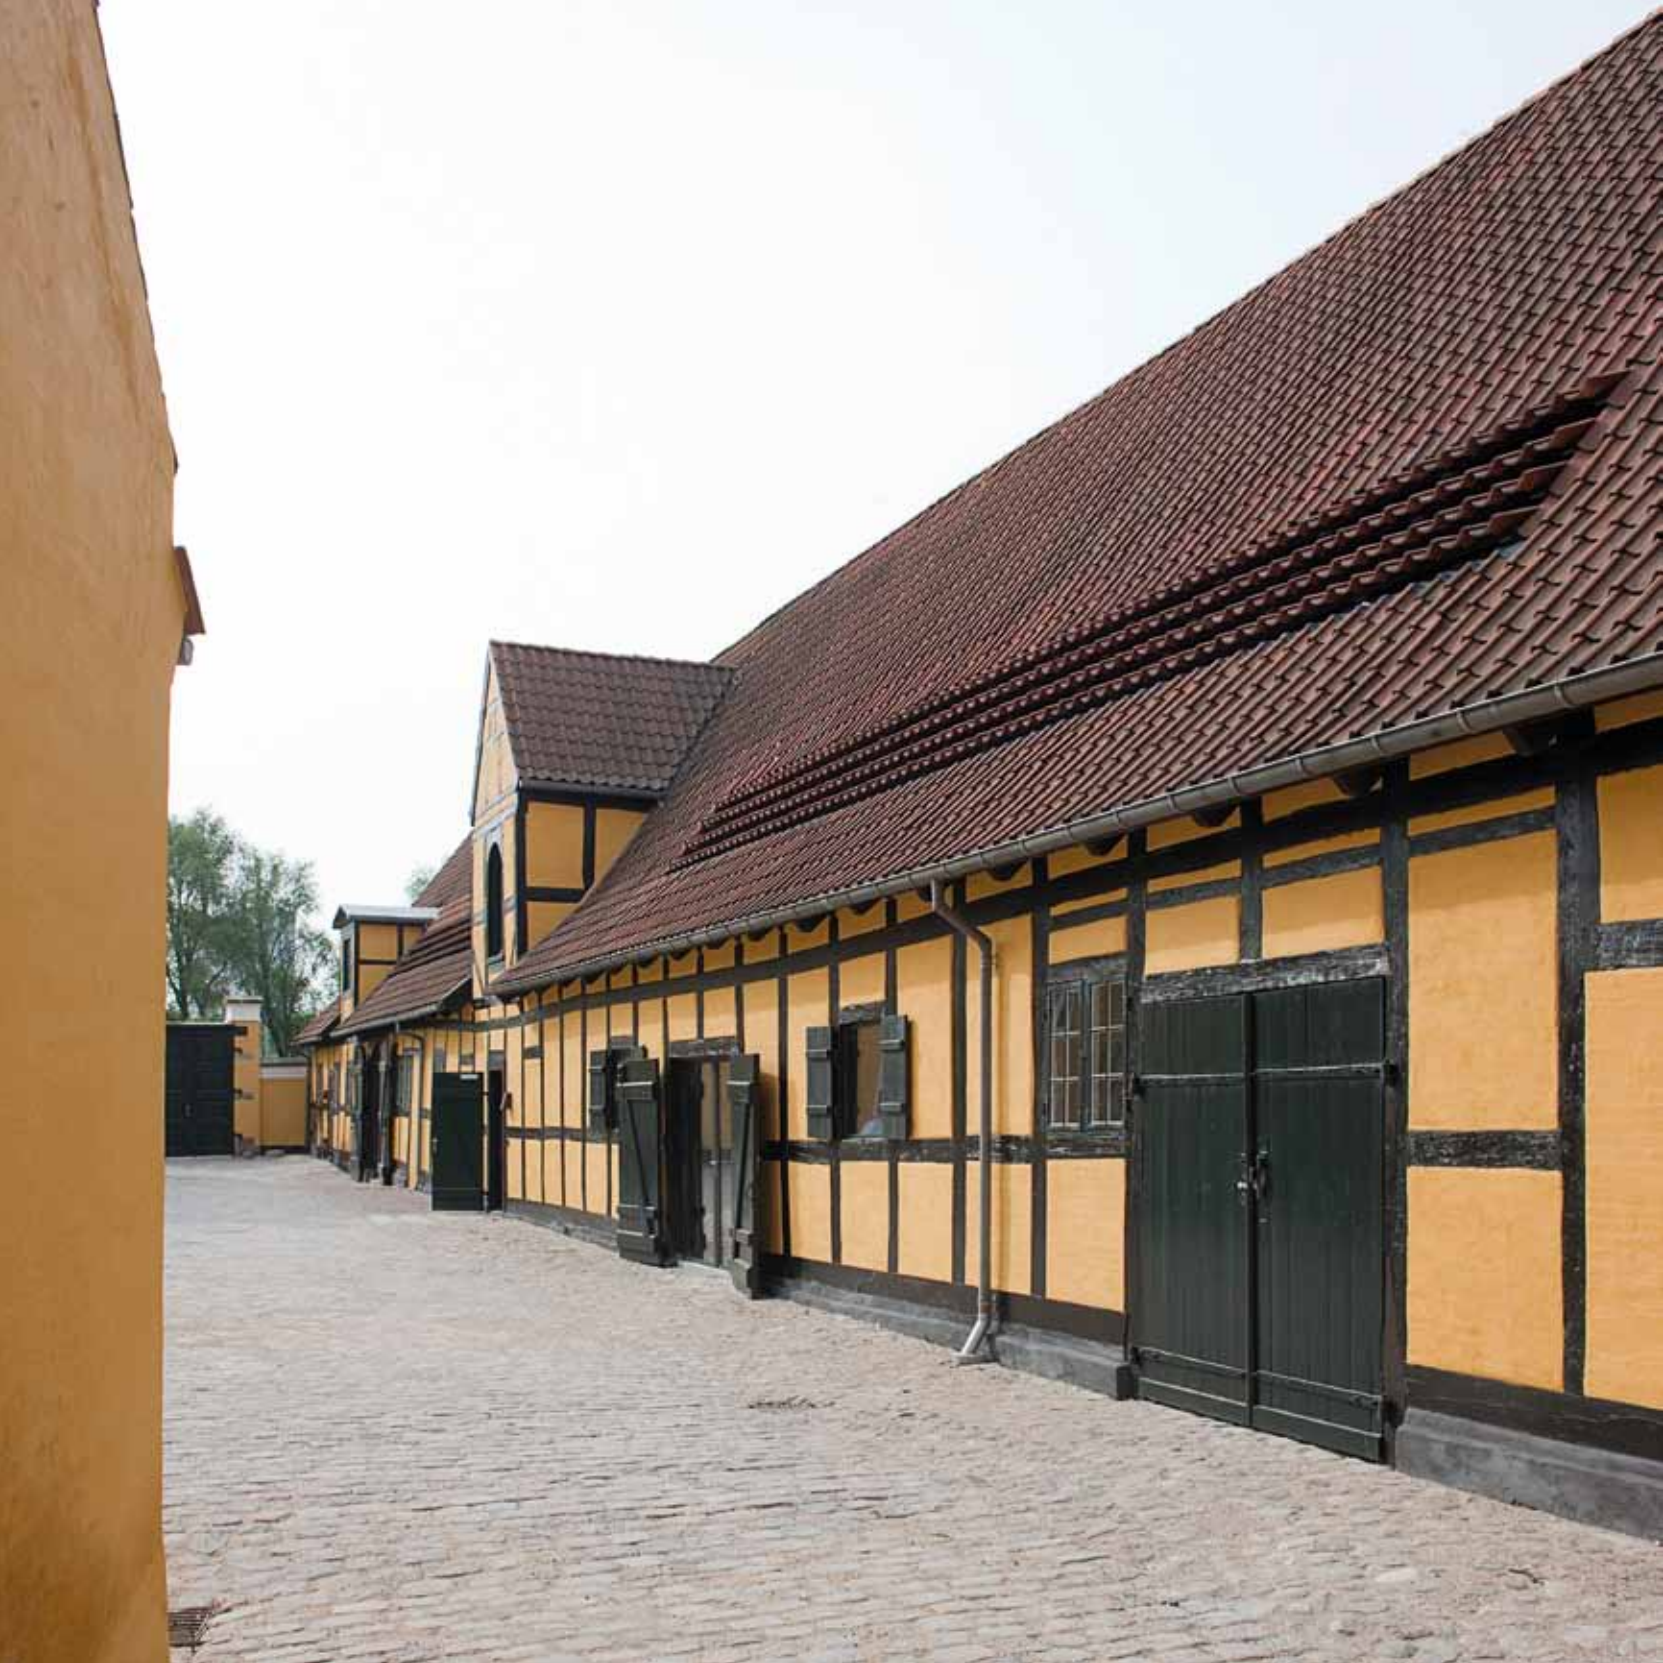
Finally, a very simple solution was found in collaboration with an external architectural consultant. Two long sections of vertical windows that open inwards mounted on top of high jamb walls are hidden by horizontal tile slats that match the tiles on the rest of the roof.

vinduer, der er monteret ovenpå høje skunkvægge, skjules af vandrette lameller af teglsten, som svarer til tagets øvrige teglbeklædning. Mellemrummet mellem lamellerne sikrer udsynet til gårdrummet, og de indadgående vinduer kan nemt rengøres. Omkostningen er en indadgående kvist, hvor efterårets løvfald, vinterens sne og forårets fugleunger givetvis vil søge hen.

that a new light intake had to be designed as a long, narrow, horizontal panel if the goal of maintaining a calm roof surface with the two front gables as the dominant feature was to be met. A model was quickly found on the south that all could accept: a long skylight along the ridge turret as the primary source of daylight. But since employees must to be able to look out a window, customary solutions were not enough.

Work started with a proposal to mount tile slats over ordinary skylights in horizontal bands at specific intervals (just as on the ridge turret) so there would still be some visibility. This design, however, would make it impossible to keep the windows clean unless a skylight that opened inward could be found. And there is simply nothing like this on the market: it would not be tight! Other proposals involved technically complicated solutions with mechanical and movable parts to ensure that the slats could be lifted when the windows had to be washed, but they proved too complex.

*Perhaps the project's boldest contribution is found on the Half-timbered Building's second story – the window.*

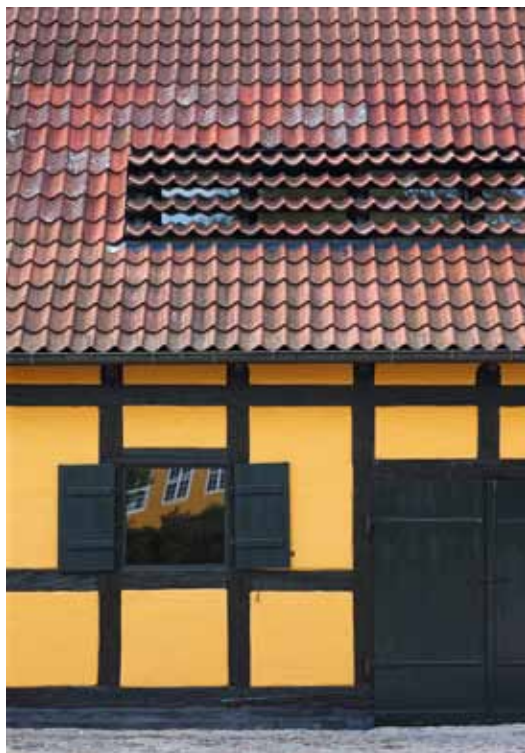
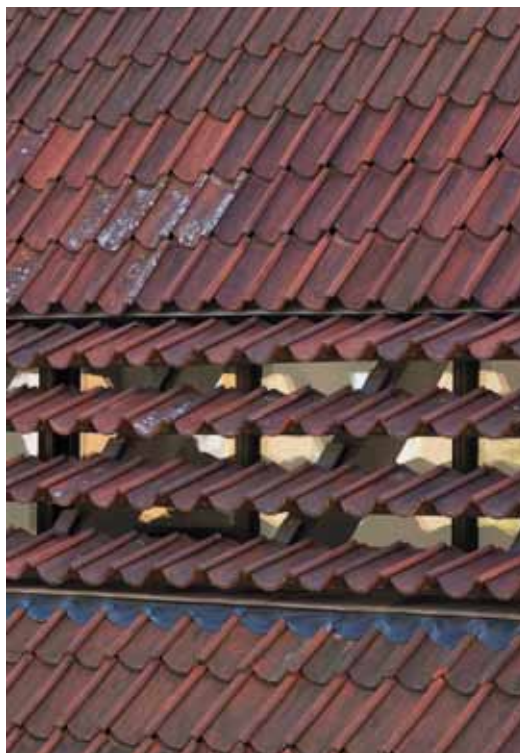
*Projektets måske dristigste indslag findes på første sal i Bindingsværksbygningen – vinduet.*
